Recurring Mass Movements on the Danube's Bank at Dunaszekcső (Hungary) Observed by Geodetic Methods

KEY WORDS: Landslide, GPS, Tilt, River bank

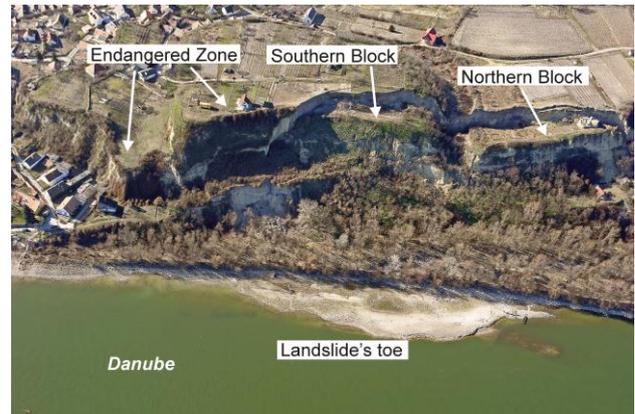
Figure 3. Oblique aerial view of the high bank at Dunaszekcső after landsliding on 12 Feb 2008. The movements spread toward the south in 2010 and 2011 (area indicated by 'Endangered Zone')

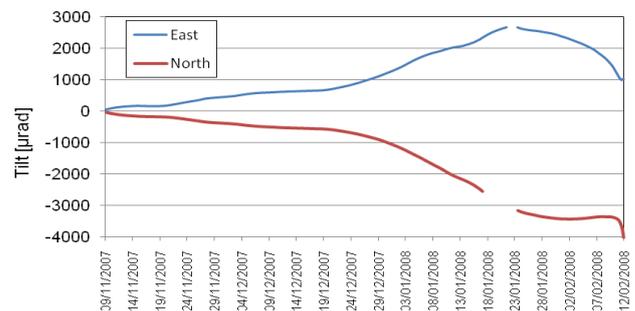
From October to mid-December 2007, horizontal movements were fluctuating, but generally they amounted to 0.3-1 mm/day with directions of ESE to SE on the northern and ENE to NE on the southern sliding block. For the same time interval (from October to December) the subsidence was in the range of 5 to 11 cm. In January, 2008 movements accelerated which then resulted in enormous subsidence (6 to 10 m) and horizontal displacements on both sliding blocks on 12 February, 2008 (Figure 3). Tiltmeter T2 clearly showed a significant backward (SW) tilt of the southern moving block before that day (Figure

Figure 4. Tilt data recorded by the tiltmeter T2 from 9 November, 2007 till 12 February, 2008. Tilting the east and north components in positive direction means tilt in east and north direction, respectively.

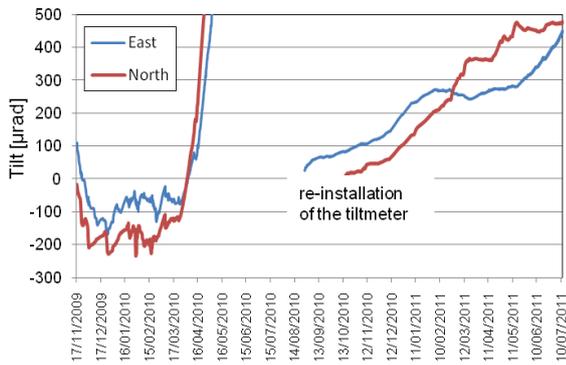
Figure 5. Tilt data recorded by the tiltmeter T2 from 17 November, 2009 till 12 July, 2011. Tilting the east and north components in positive direction means tilt in eastern and northern directions, respectively.

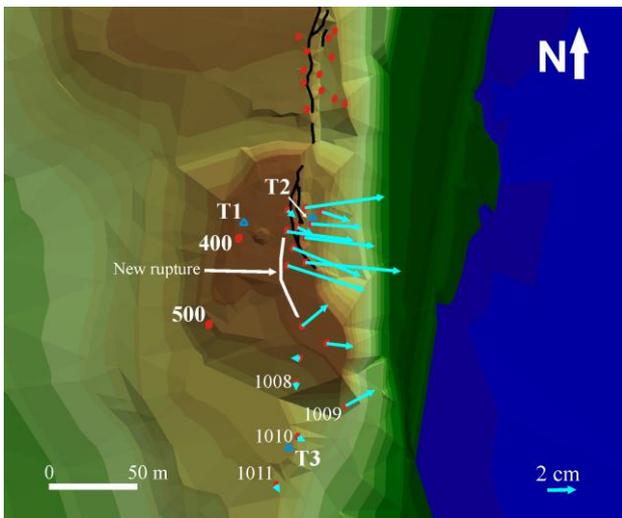
4). For March, 2008 horizontal movements decreased to the same magnitude (0.3-2 mm/day) as it was measured during October and November, 2007. In three consecutive years horizontal displacements were in the range of 1 to 4 cm/year with a clear eastern component (towards the Danube) which matched well with the record of tiltmeter T2 (Figure 5). In winter 2009 tiltmeter recorded some oscillations which meant that the southern block lost its balance and it could not get into a new equilibrium state. As a consequence of this, the block tilted very strongly in NE direction and this tilt also continued after the second re-installation of the instrument in 2011. The subsidence of the block amounted to 2 to 5.5 cm/year and the southern block showed slightly larger movements than the northern. For the autumn and winter of 2010 and during the spring of 2011 deformations accelerated again and spread towards the southern part of the Vár Hill as it is shown in Figure 6.

Figure 6. Horizontal displacements as shown by GPS vectors for the time interval 22 March, 2010 – 18 April, 2011. Note that the movements of the northern block are not presented here.

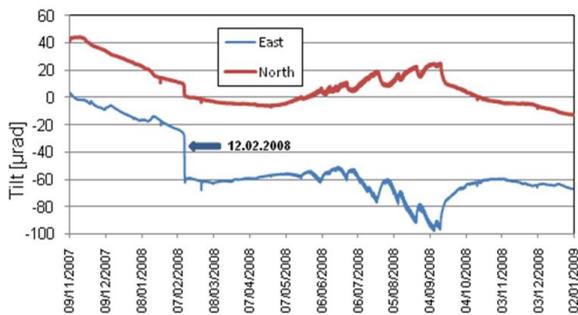
Figure 7 and 8 show tilt data measured by the tiltmeter T1 from 9 November, 2007 till 31 December, 2008 and from 22 April, 2007 till 7 July, 2011. It can be seen that after the slump of the unstable block on 12 February, 2008 (Figure 7) the remaining part of the southern block moved by oscillating tilting till October, 2009 (Figure 8) and then it was tilting in SE direction pushing the unstable section and the endangered zone of the high bank (Figure 3). The observed tilt is in very good coincidence with the horizontal displacements measured by GPS (see Figure 6).

Figure 7. Tilt data recorded by the tiltmeter T1 from 9 November, 2007 till 31 December, 2008. Tilting the east and north components in positive direction means tilt in eastern and northern directions, respectively.

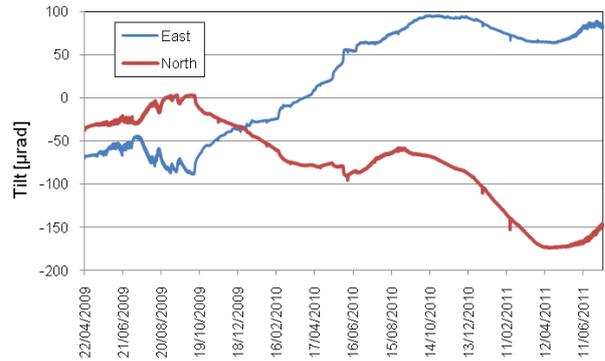
Figure 8. Tilt data recorded by the tiltmeter T1 from 22 April, 2007 till 7 July, 2011. Tilting the east and north components in positive direction means tilt in east and north direction, respectively.

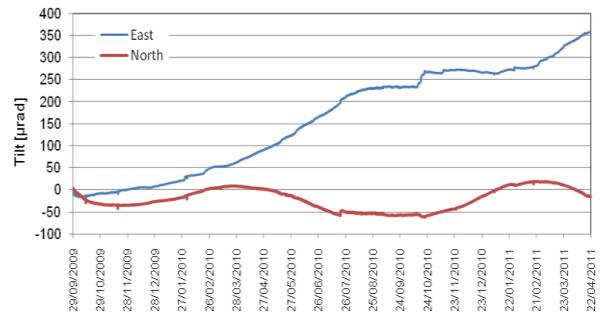
Figure 9 displays tilt data recorded by the tiltmeter T3 on the endangered zone from 29 September, 2009 till 22 April, 2011. This diagram shows a considerable tilt in east direction and a small alternating tilt in N-S direction. The GPS measurements indicate a NE horizontal movement at the point 1009, while

almost no horizontal movements were detected at points 1010 and 1011.

Figure 9. Tilt data recorded by the tiltmeter T3 from 29 September, 2009 till 22 April, 2011. Tilting the east and north components in positive direction means tilt in east and north direction, respectively.
