Polyphyton Dam: Monitoring of the Right Abutment Slide

Spyridon Raftopoulos¹

Key words: crack meter; total station; slide; unstable area; monuments

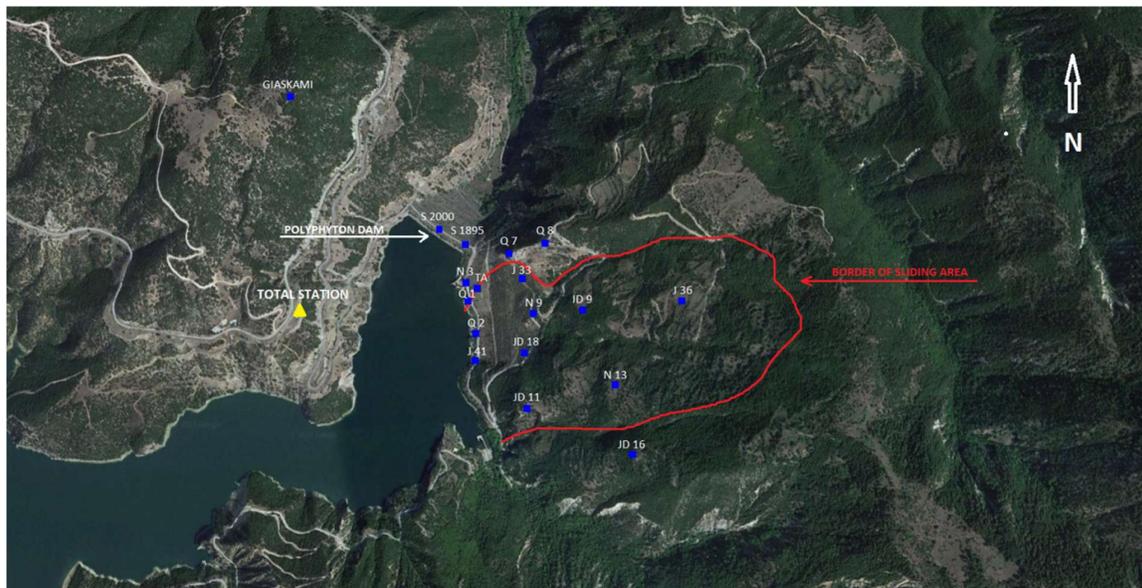
An **unstable area** (Alexis area Fig 1), located in the

Figure 1. Polyphyton Dam border area. Alexis slide

right abutment, upstream of and in the vicinity of the Dam is critical for the Dam safety. This particular area could potentially affect all supplementary parts of the project, such as the Inlet of Power Intake and Spillway, as well as the upstream shell of the Dam.

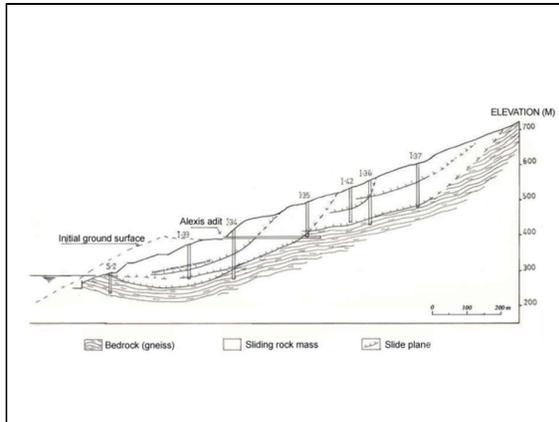
Figure 2. Polyphyton HEP. Geological section of the right abutment upstream dam (Alexis area)

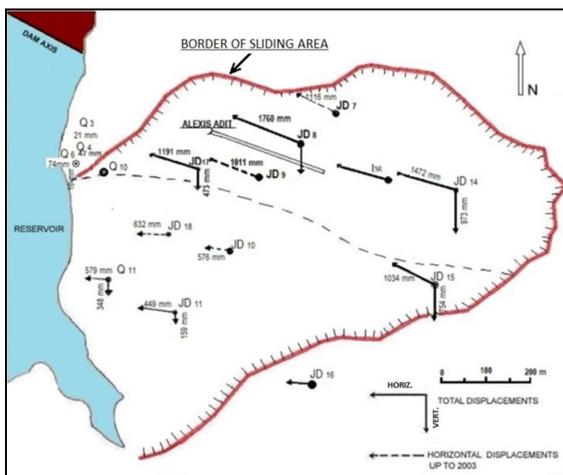
Deformation rate just after the excavation procedure in the year of 1972 was at maximum 1,5 mm per day. After all stability measures had been taken, deformations were on progressive degradation. Consequently after two years (in 1974), movements did not surpass 0,5 mm per day, while after the year of 1982 they fluctuated between 0,1 and 0,2 mm per day, respectively. Nowadays, deformations at the Alexis region are a few up to 10 millimeters per year in the majority of the places, as well as locally. The South part of the slide movements slightly exceed 2 cm at maximum per year. Total displacements at characteristic spots of the Alexis area for period 1974-2015 are depicted on Figure 3.

Precipitation appears to be the main factor affecting the stability of the area as well, less than the reservoir level fluctuation during May and June.

Figure 3. Alexis area. Displacements of monuments. Period 1974-2015

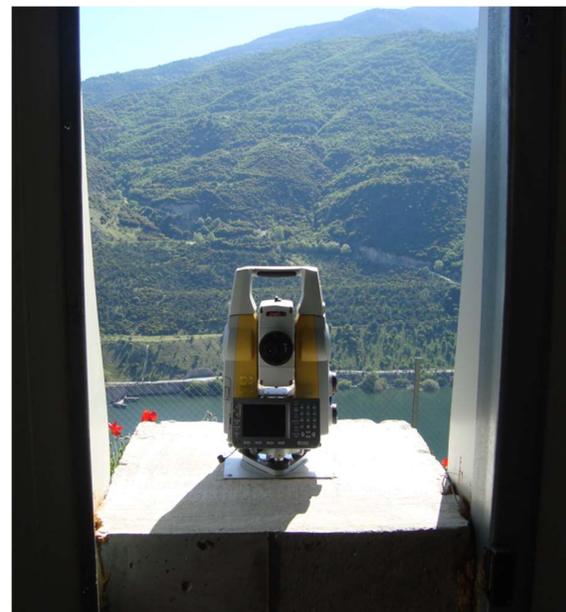
A robotic instrument is set in a concrete mount (Figure 4) founded on the stable bedrock at the opposite side of the Alexis area, on the left abutment.

Figure 4. Total Station on left Abutment

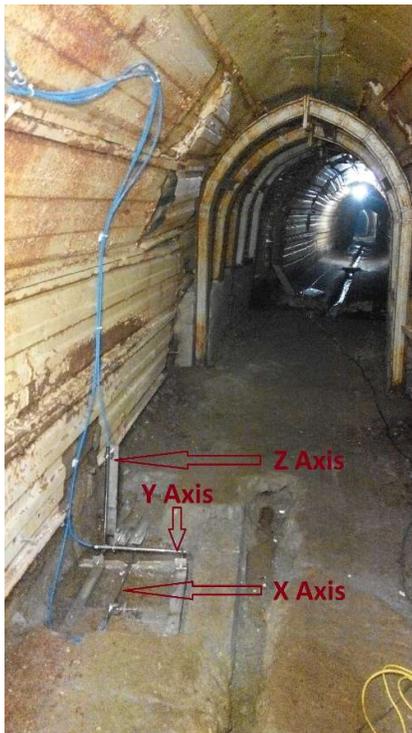
On the other hand, a crack meter is installed on the floor into Alexis adit (Fig. 5), in order to control movements from the inside of the sliding mass. In that sense, concerning the data coming from the internal of the adit they are more representative than the superficial measurements.

Figure 5. Alexis adit crack meter

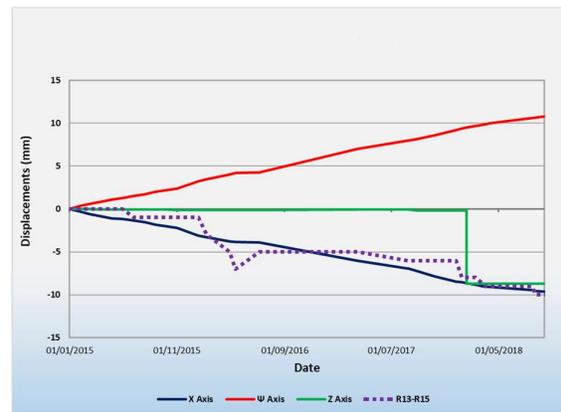
The only discordance of the measurements between the crack meter and topographical process is the variation in vertical deformations. Measurements from the crack meter have more or less a very smooth variation at any dimension. However, a significant gap arose on 30/1/2018, when the part of the adit floor located towards to the inlet was rapidly and at once settled down for 8,5 mm. This rate practically represents the whole vertical displacement of the sliding area within the reference period of the past four years. A proportional gap was also found during the topographic vertical measurements, between

January and June of 2016, approximately one year and a half earlier than the crack meter's specific indication. Moreover, there was a slight difference regarding the crack meter indicated value and the displacement rate. It has to be underlined that the topographic measurement points besides the crack meter (monuments R 13 and R 15, Fig.6) are 13 m and 6,5 m far from it. The internal sliding parts of the whole sliding mass, are moving independently, tilting while raising their back side, before they are deformed. In that sense, it could be a reasonable justification for the rate discordance between the crack meter and the other measurements regarding the vertical deformations. All of this aside, the specific behavior of the unstable mass, may be an indication of the sliding mechanism, as the first deformation occurs on its external body as a bending. Consequently, the accumulative stress is burdening the existing shear zones, and after exceeding the sliding surfaces residual strength, it rapidly slips within them.

Figure 6. Alexis adit. Traxial rock meter vs Topographic vertical displacement measurements

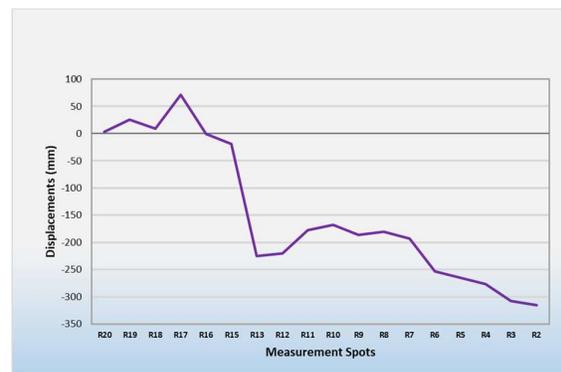
Figure 7. Alexis adit. Total vertical displacements during 1984-2018
