## MONITORING AND DEFORMATION ASPECTS OF LARGE CONCRETE FACE ROCKFILL DAMS

**Abstract:** Concrete face rockfill dams (CFRDs) are gaining a worldwide recognition as the most economical type of dams to be constructed in extreme northern and sub-Antarctic regions. Height of CFRDs may exceed 200 m. Safety of CFRDs depends on the proper design, construction, and monitoring of actual behaviour during the construction and during the operation of the structure. The main concern for the safety of CFRDs is the deformation of the concrete face. During the reservoir filling, the load of the water and deformations of the dam rockfill, force upstream concrete slab to deform. The displacements of the concrete face during the reservoir filling should not exceed the maximum allowed values in order to maintain the structural integrity of the concrete face. In a classic CFRD where the concrete face is constructed after the end of construction of the rockfill embankment, it is very important to estimate the displacements of the concrete face during the filling of the reservoir and to verify if these displacements are lower than displacements compatible with the structural integrity of the concrete fa

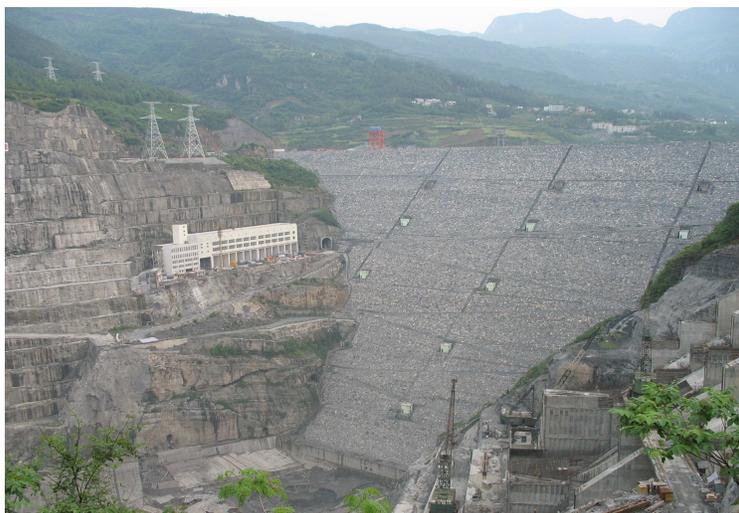
Shuibuya CFRD is presently the highest of its kind in the world. It is 233 m high and 608 m long (Fig. 1). The crest width is 12m with a 5.2m high "L" shape parapet at the crest. The upstream dam slope ratio is 1:1.4 and the downstream slope ratio is 1:1.25. The concrete slab is 0.3 m thick at the top and 1.1m thick at the bottom. The slab area is 127 000 m<sup>2</sup> and the maximum inclined slab is 392 m long. The slab is divided into three construction stages with two construction joints at elevation 280 m and 360 m.

Figure 1 - Shuibuya dam.

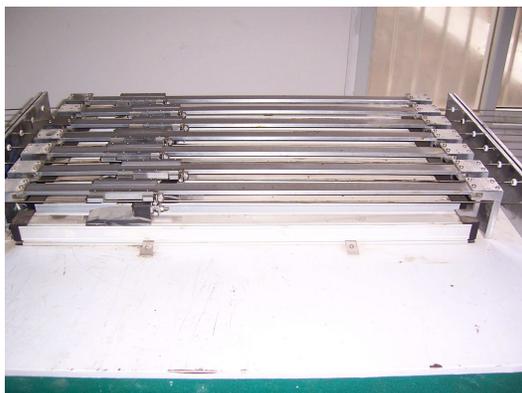
The geotechnical monitoring using interior wire extensometers to monitor interior displacement of the points located in the rockfill was started at the beginning of the filling up of the reservoir. The interior wire extensometer is shown on Fig. 3. The location of the monitored points is shown in Fig. 4. The measured settlements of point 25, point 29, and point 32 during the filling up the reservoir are given in Fig. 5, Fig. 6, and Fig.7 respectively.

Figure 3 - Interior wire extensometer.
