MONITORING OF THE MAIN SPIRE OF THE DUOMO DI MILANO

KEY WORDS: Duomo di Milano, Fiber Bragg Grating (FBG), Structural Health Monitoring, Alarm System

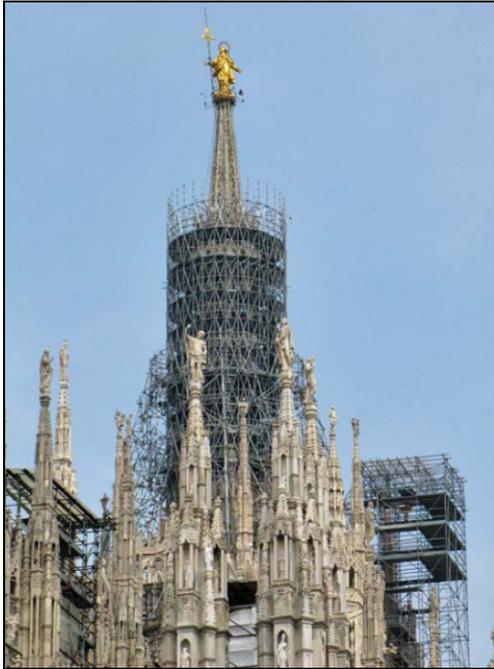
Figure 2. The main spire of Duomo di Milano cathedral with the 'Madonnina' statue at the top.

The restoration of the main spire of the cathedral is now the main planned priority (Figure 2). Related works started in summer 2010. The spire hosts a popular statue designated as 'Madonnina', which is assumed as the symbol of the city. Recent checks found a main degradation of the decorative marble surfaces, with the chance that some parts could fall down. Urban pollution has been undoubtedly an important cause of degradation here, but also the thermal stresses has had a relevant impact. Indeed, the structure is 108 m tall and has been fully exposed to sun, rain and pollution for centuries.

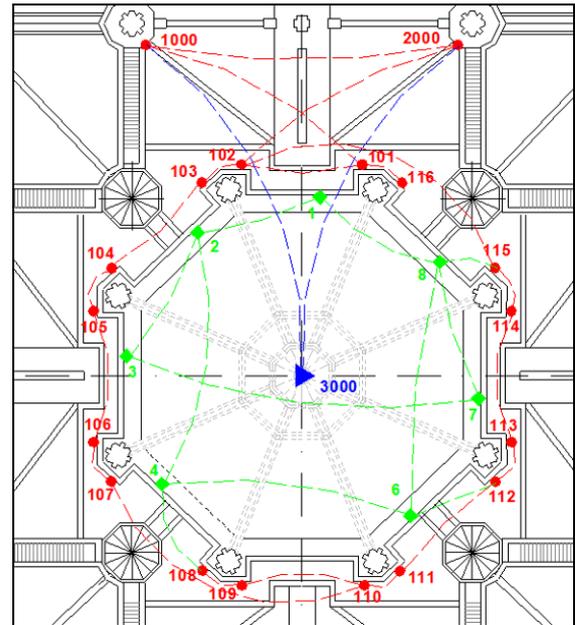
Figure 3. Layout of the geometric levelling network at the base of the dome. Green and red lines represent the internal and external networks, respectively. The blue point (3000) is hung on a cable that is connected to the top of the spire.

The vertical displacement of the dome can be measured with a leveling network. A series of stable benchmarks was mounted on the structure. The overall layout comprehends 27 points as shown in Figure 3: 7 are located inside the structure on special shelves (Fig. 4) that allow the stable connection of rods (with the possibility of setting up the optical level as well); 16 points on the external wall; 2 points on small spires; one permanent rod connected to the top of the spire with a metal wire.

In correspondence of the leveling network (green lines in figure 3) a planimetric network was planned in order to measure the convergence of the ribs of the dome (see Fig. 6). Measurements are carried out by robotic total station TCA 2003 and the point position is measured with an average precision of ± 0.4 mm. During this operation, the instrument has been placed on the same plates (Fig. 4) used as standpoints for optical leveling.

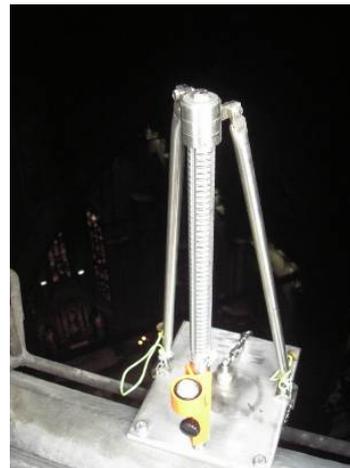
Figure 4. Plate for small leveling rod, optical level or total station.

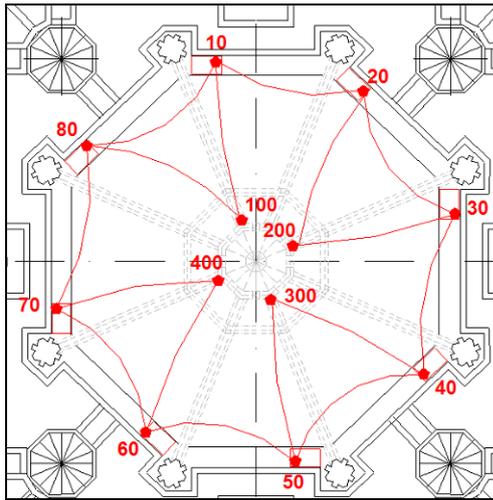
Figure 5. Geometric leveling at the base of the spire

A second leveling network was installed on top of the dome, where the spire is based. As can be seen in Figure 5, this network is made up of 12 points that are connected to the lower part of the spire with some extensometers. This allows a direct link between the levelling networks and gives the possibility to adjust the dataset together.

Measurement have been done with a Zeiss Ni1 optical level obtaining a precision of about ± 0.1 mm.

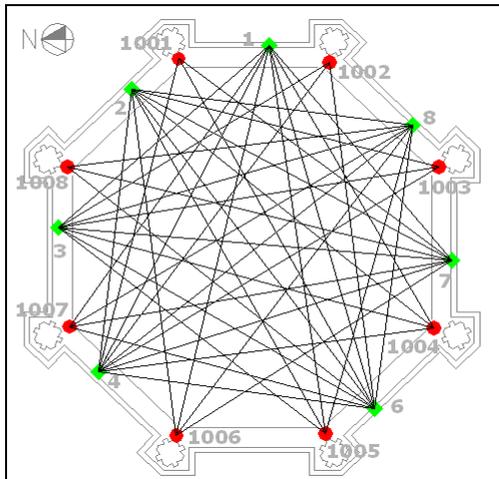
Figure 6. Planimetric network at the base of the dome

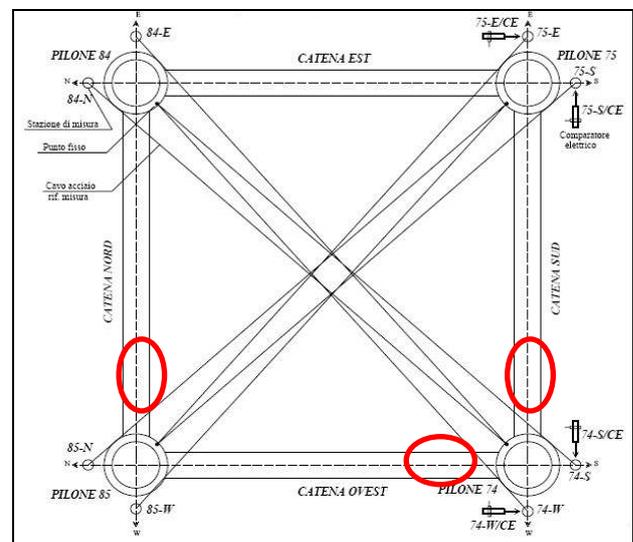
Figure 7. Extensometer cables and the position of the vibrating wires strain gauges (in red).

The distance variations of the big pillars of the dome cladding are measured with 8 extensometer tapes (34 m above ground). This system is not new, as the same solution was adopted in 1984 for the restoration work of the pillars. However, the system was re-established and automated in 2008. The position of the sensor is illustrated in Figure 7.

The system is based on the *vibrating wire* strain gauges VK4100 produced by SISGEO, which were connected to the northern, western and south sides of the structure. The location of all sensors is shown in Figure 7.

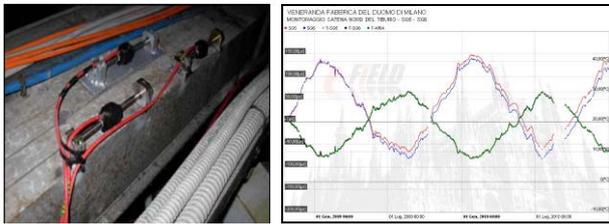
Figure 8. On the left, an image of the vibrating wire strain gauges installed. On the right, the variation of a couple of sensors (blue and red lines) and the corresponding temperature (green line).

For each chain, a couple of sensors was installed with a small relative distance (Fig. 8). In addition, a thermometer was applied to the western chain to measure air temperature.

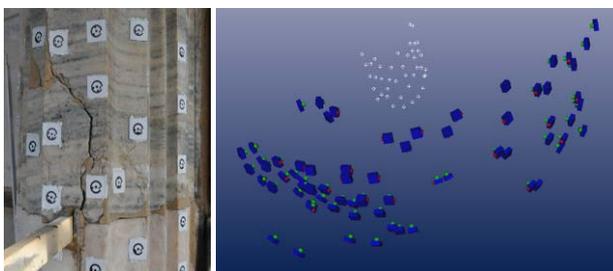
Figure 9. Cracks are investigated using a photogrammetric block and a series of coded targets.

A series of coded target (Fig. 9) was applied to the pillar and was imaged with a Nikon D700 (roughly 70 images). 3D target coordinates were estimated with a bundle adjustment, where a calibrated bar was employed to remove the scale ambiguity. The final results is a list of distances between all target combinations.

To check the accuracy several block of images were acquired and processed independently. The time between different epochs was quite limited, therefore without an expected target movement. The statistics showed a discrepancy of about ± 0.02 mm (the object is 40 cm wide) for points lying on the same side.

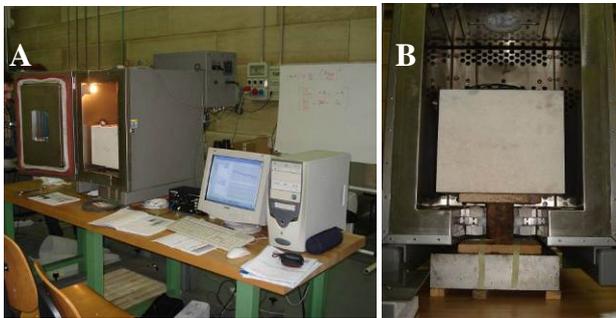
Figure 10. (a) The thermal chamber with the setup for the calibration of FBG. (b) Detail of the inner thermal chamber with the block of marble inside.

To obtain the relationship between the temperature T and the thermal strains $\epsilon_1 = (\epsilon_2 + \epsilon_3)$, a calibration setup was prepared in Politecnico di Milano laboratory (Fig. 10a). A sample block of 'Candoglia' marble was put inside a thermal chamber (Fig. 10b) which is able to maintain a stabilized temperature. The same sensors that were placed later on the Duomo ribs were used for this calibration, except for the type "A" that must be glued and so it cannot be re used. The dimensions of the marble block were $350 \times 300 \times 250$ mm³, nearly the maximum values that can be placed inside the chamber. The sensor direction was selected to match the one of the vaulting-ribs. The tested temperatures were selected in the range from 5 C to +40 C, at about 5 C steps, to cover all the possible values inside the cupola during a year. Many of the tested temperatures were tested twice or three

times to check repeatability. Due to the dimensions of the block, a minimum testing time of 12 h (usually 24 h) was adopted before reading the output values: all the transient phase was acquired so that a steady state condition was verified.

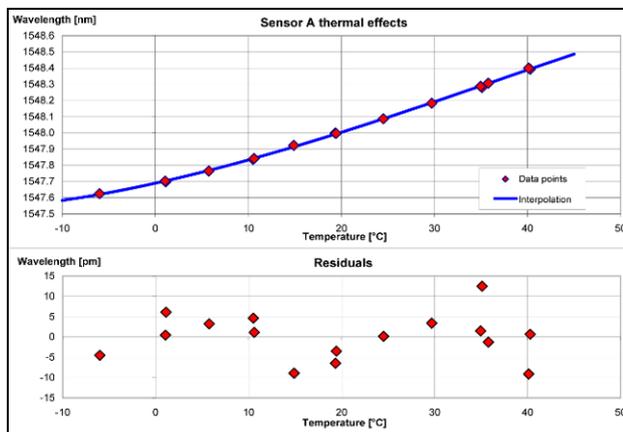
Figure 11. Thermal calibration results of the two strain sensors used in the preliminary phase.

The analysis of the temperature tests are summarized in Figure 11, where the raw data points are interpolated with a 3rd degree polynomial. At the bottom of the figure, the residuals are shown, i.e. the differences between the measured data and the interpolation. To understand which sensor should provide the best signals, an uncertainty analysis of the thermal calibration was carried out (Cigada et al., 2011).

This work demonstrated that an a-posteriori thermal compensation is a feasible solution for the monitoring of Duomo di Milano, and, more in general, for any structure showing big thermal inertia. The first results from one of the installed sensors show nearly zero mechanical loads, as expected and also desired. The first step of this work allowed to estimate the minimum measurable strains, that are in the order of 20 $\mu\text{m}/\text{m}$.

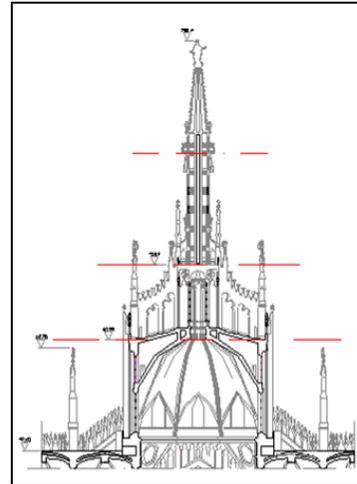
Figure 12. Position of the inclinometer sensors

The inclinometer sensors were used to measure the inclination of the different part of the main spire. The instruments chosen for this purpose are Precision Biaxial Tiltmeter (model 98046-01 'Tuff Tilt 420' - Codevintec, 2011). In total 5 inclinometers were installed (see Fig. 12):

- 3 around the base of the main spire on the spurs, with a distribution of 120°;

- 1 in correspondence of the first terrace;
- 1 above the 'Madonna' on the last terrace.

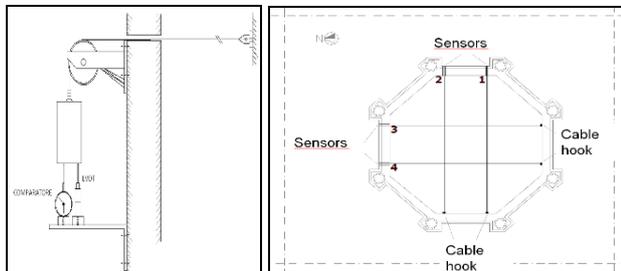
Figure 13. Position of extensometer sensors (right) and scheme of sensors (left).

The basement of the dome is a very important structural element because it transmits the roof and scaffold weight to four pillars. For this reasons, in addition to the total station measurements described at paragraph 2.2, a new automatic control system was planned. Four cable extensometer was installed as reported in Figure 13. Each extensometer (Fig. 13 left) consists of an INVAR cable that is tensioned by a weight, and two sensors. The first is used for automatic reading and the second (manual) for backup. The automatic sensors are LVDT Inelta IEDT50 (stroke ± 25 mm, linearity tolerance < 0.75 % F.S. - INELTA, 2011).

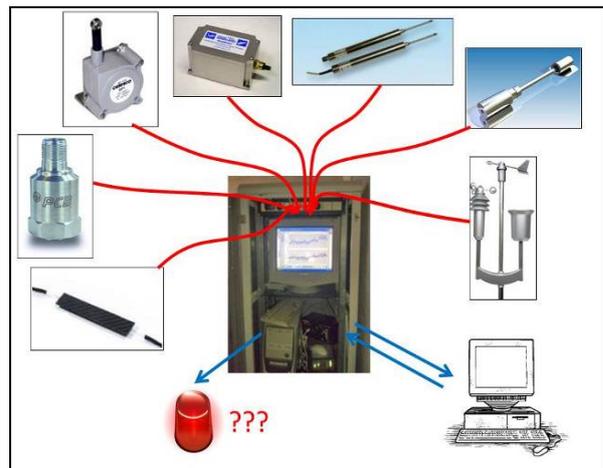
Figure 14. Scheme of system of data acquisition, remote control and alarm.

All automatic sensors send data to a unique collection center (Fig. 14). An *interrogation unit* (IU) is installed on PC in a protected position. Under normal operating conditions, its main task is to collect and analyze the data stored in the peripheral nodes, thus becoming the final destination of all data. During set-up phases, it constitutes the user-interface for node configuration and sensor calibration. The IU also serves as the gateway for remote access to the system through the Internet.
