Efficient Cadastral Survey Methodology In Natural Disaster region - Case study in Korea -

[BongBae, JANG] Republic of Korea

27th of Sep. 2018
Bergen Norway

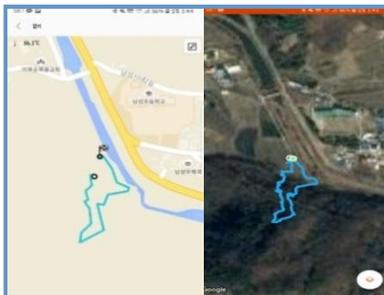
[Method 1]
Tracking App

Utilize App -> measure destroyed area

Time	26min/ 3min
Area	3,000m ²
Difference	-339m ²
Result	Rapid info. No Equipment

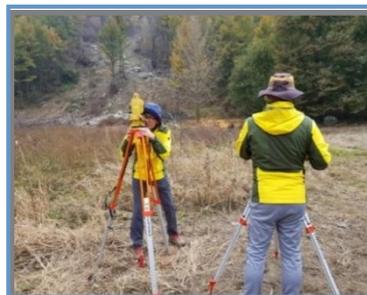
[Method 2]
T/S

Measure Destroyed area

Time	58min/ 7min
Area	3,339m ²
Difference	Standard
Result	Difficult measuring

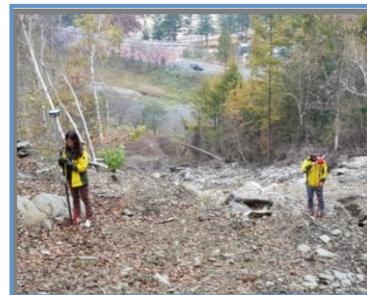
[Method 3]
RTK

Obtain coordinate

Time	37min/ 15min
Area	3,454m ²
Difference	115m ²
Result	Multipath

RTK is the most suitable method (Direct measurement method with rapid and good accuracy)

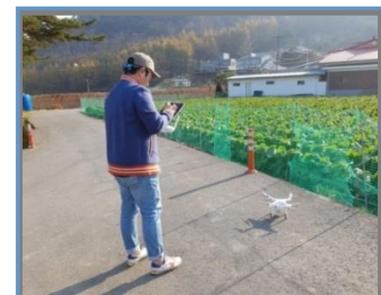
[Method 4]
UAV

Acquire Ortho-photo

Time	28min /240min
Area	3,622m ²
Difference	283m ²
Result	Safe location various uses

UAV provides a highly accurate ortho-images and can be used for various disaster monitoring

UAV is one of the most effective and efficient methodologies for landslide

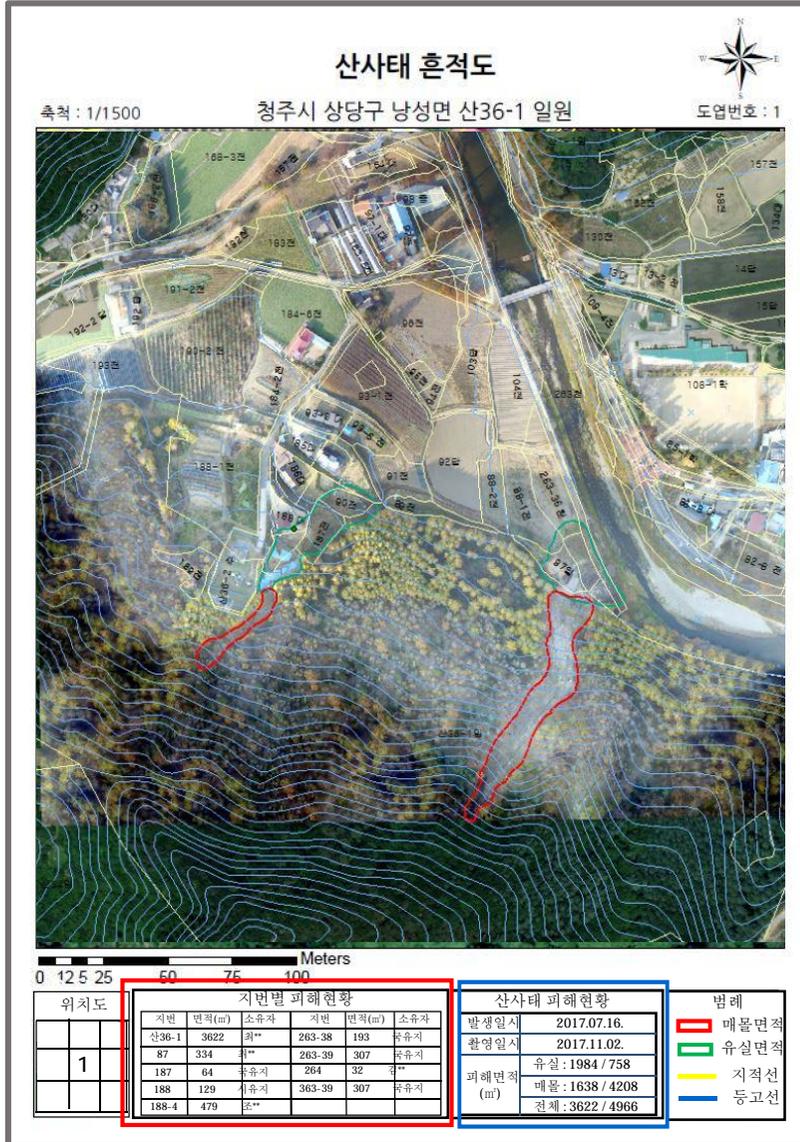
2. Landslide Maps

① Attribute data

§ Orthphoto, 3D Image, Video, DATA of destroyed areas

<산사태 흔적도 정보>

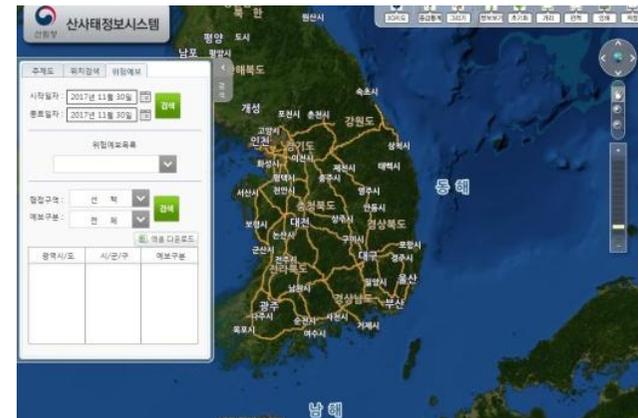
<Landslide Information System>

② Application

- § Report to VIP
- § Certification for damaged level
- § Data Upload in Real-Time
- § Masterplan for Damage reduction

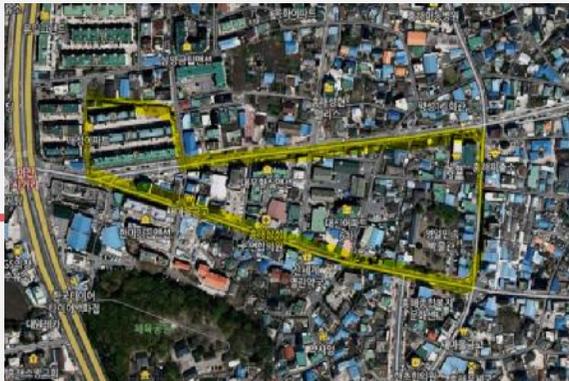
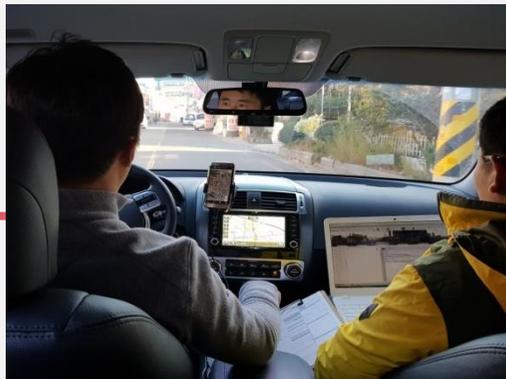
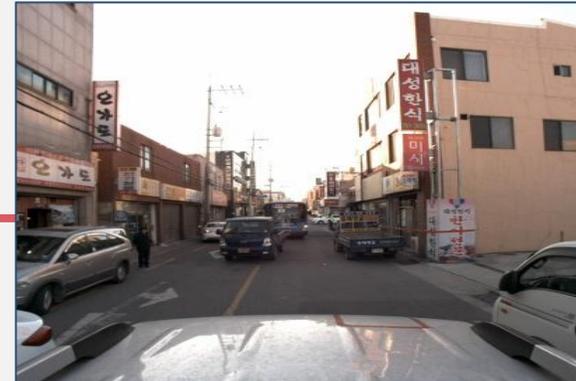
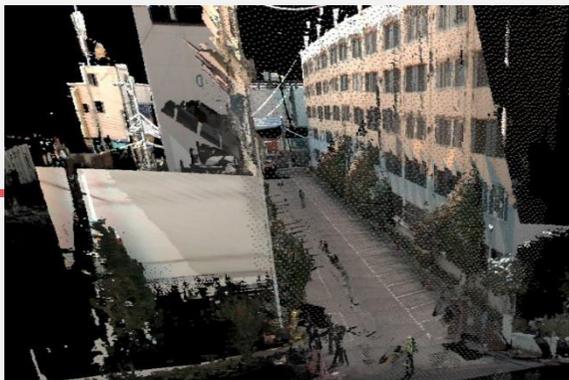
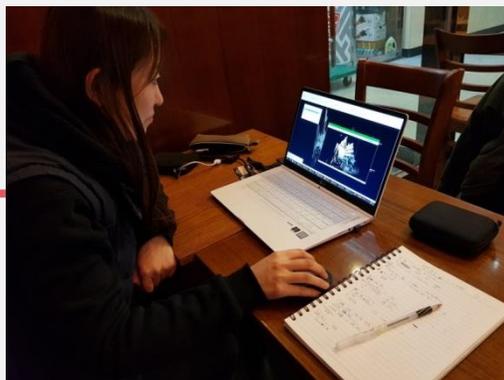
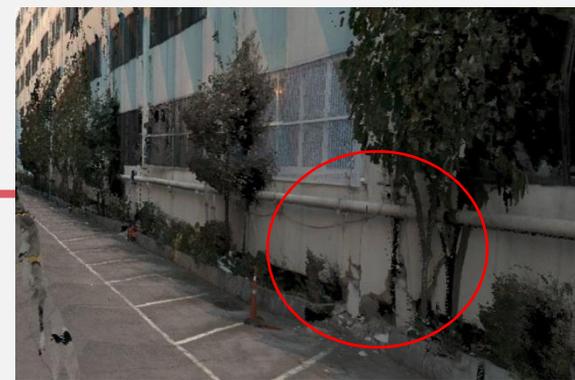
MMS procedure

① Decide area

② MMS

③ Acquire image

④ scanning(Point cloud)

⑤ processing

⑥ results

*MMS(Mobile Mapping System) : rapid data acquisition method for 3D images with Camera, Laser scanner, GPS, INS, etc.

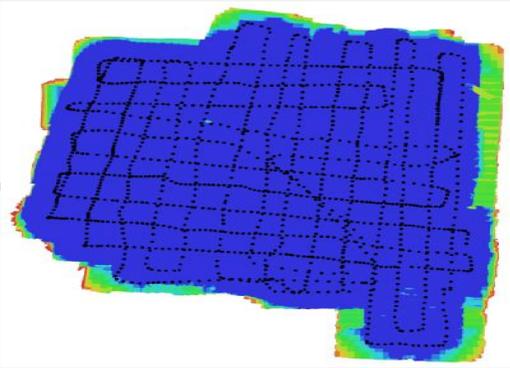
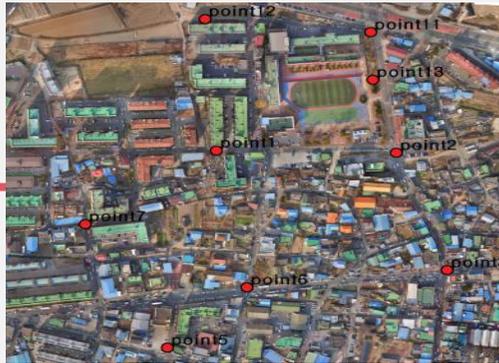
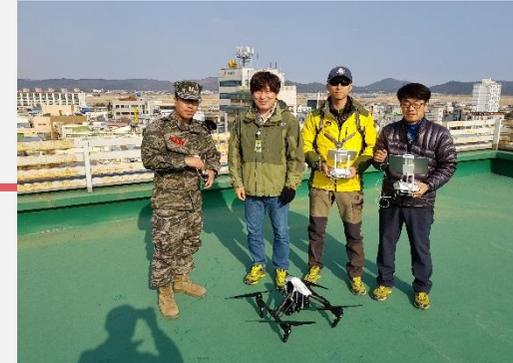
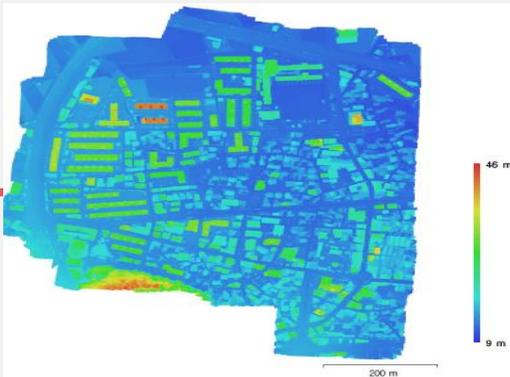
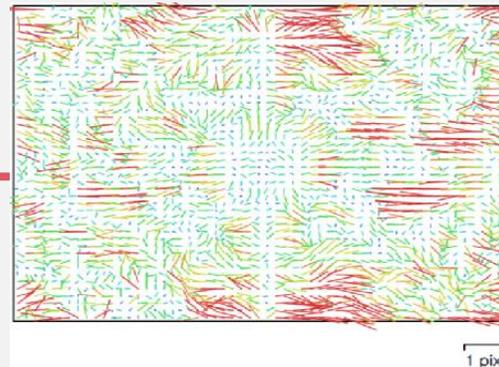
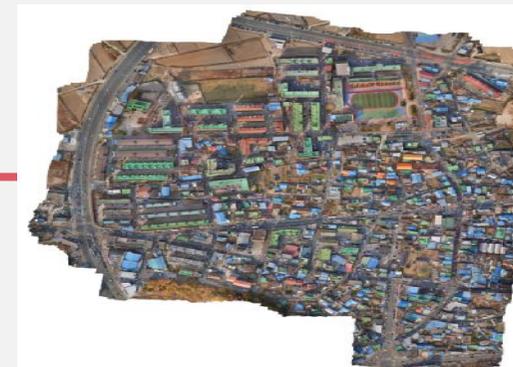
UAV survey procedure

① Planning

② GCP surveying

③ Data collection(flying)

④ Digital Elevation Modeling

⑤ processing

⑥ results

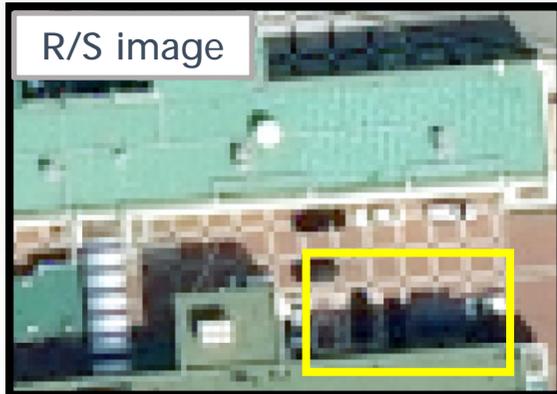
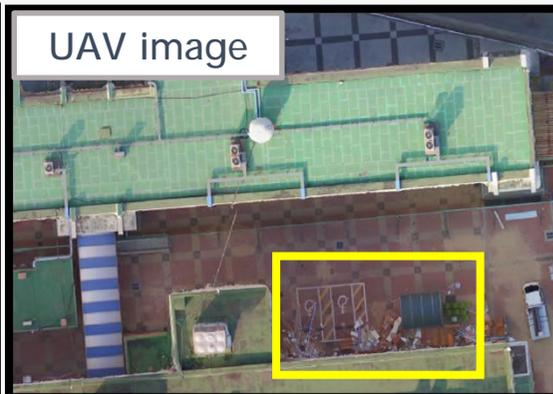
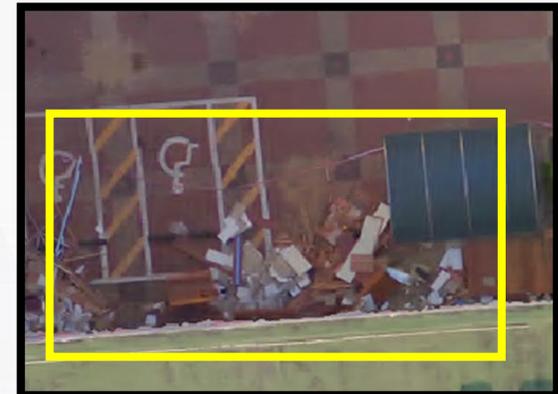
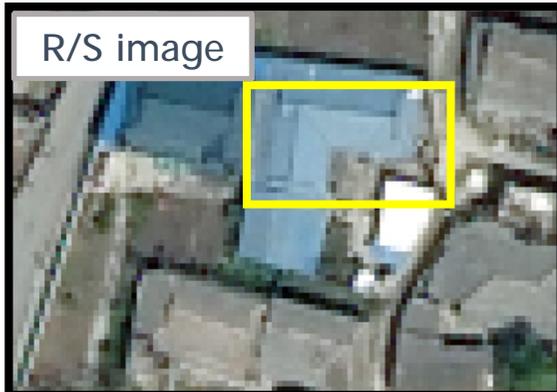
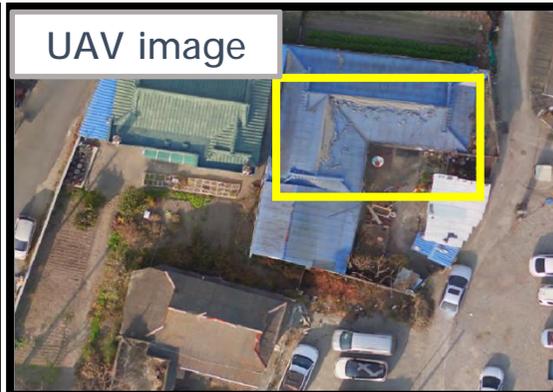
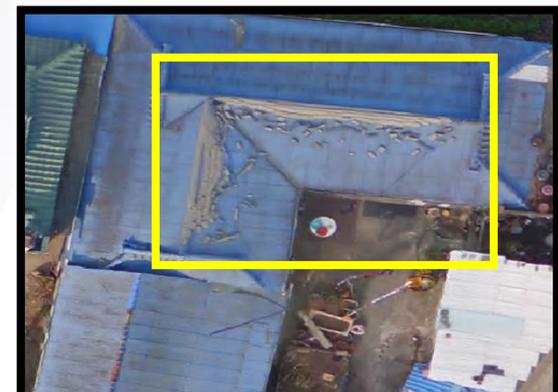
UAV mapping & decipher

It is possible to judge the damage at location where it is impossible to survey

(narrow road, roof)

offer a few centimeter spatial resolution

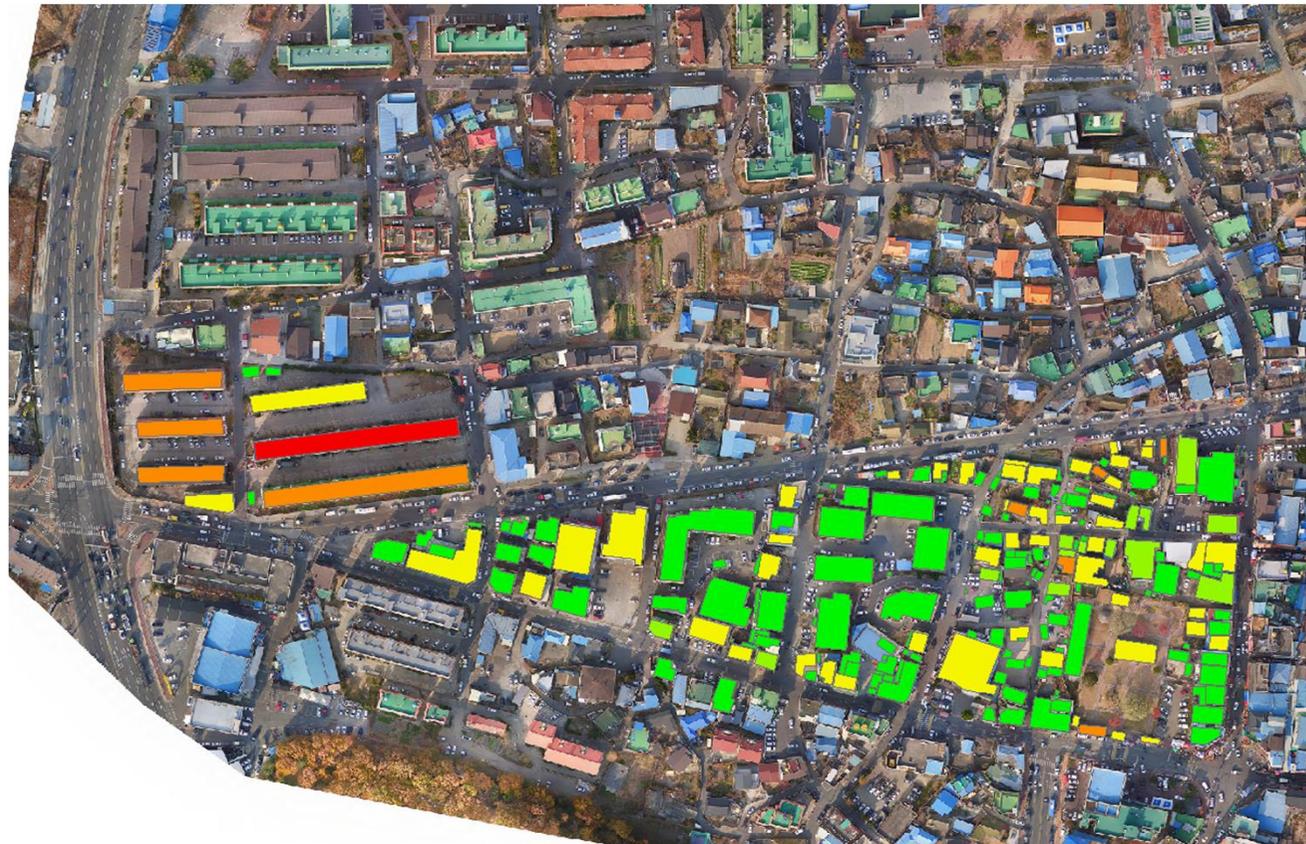
Building damage classification

MMS(slope, well crack, damage) + UAV(well damage, roof damage)

classification about building damage

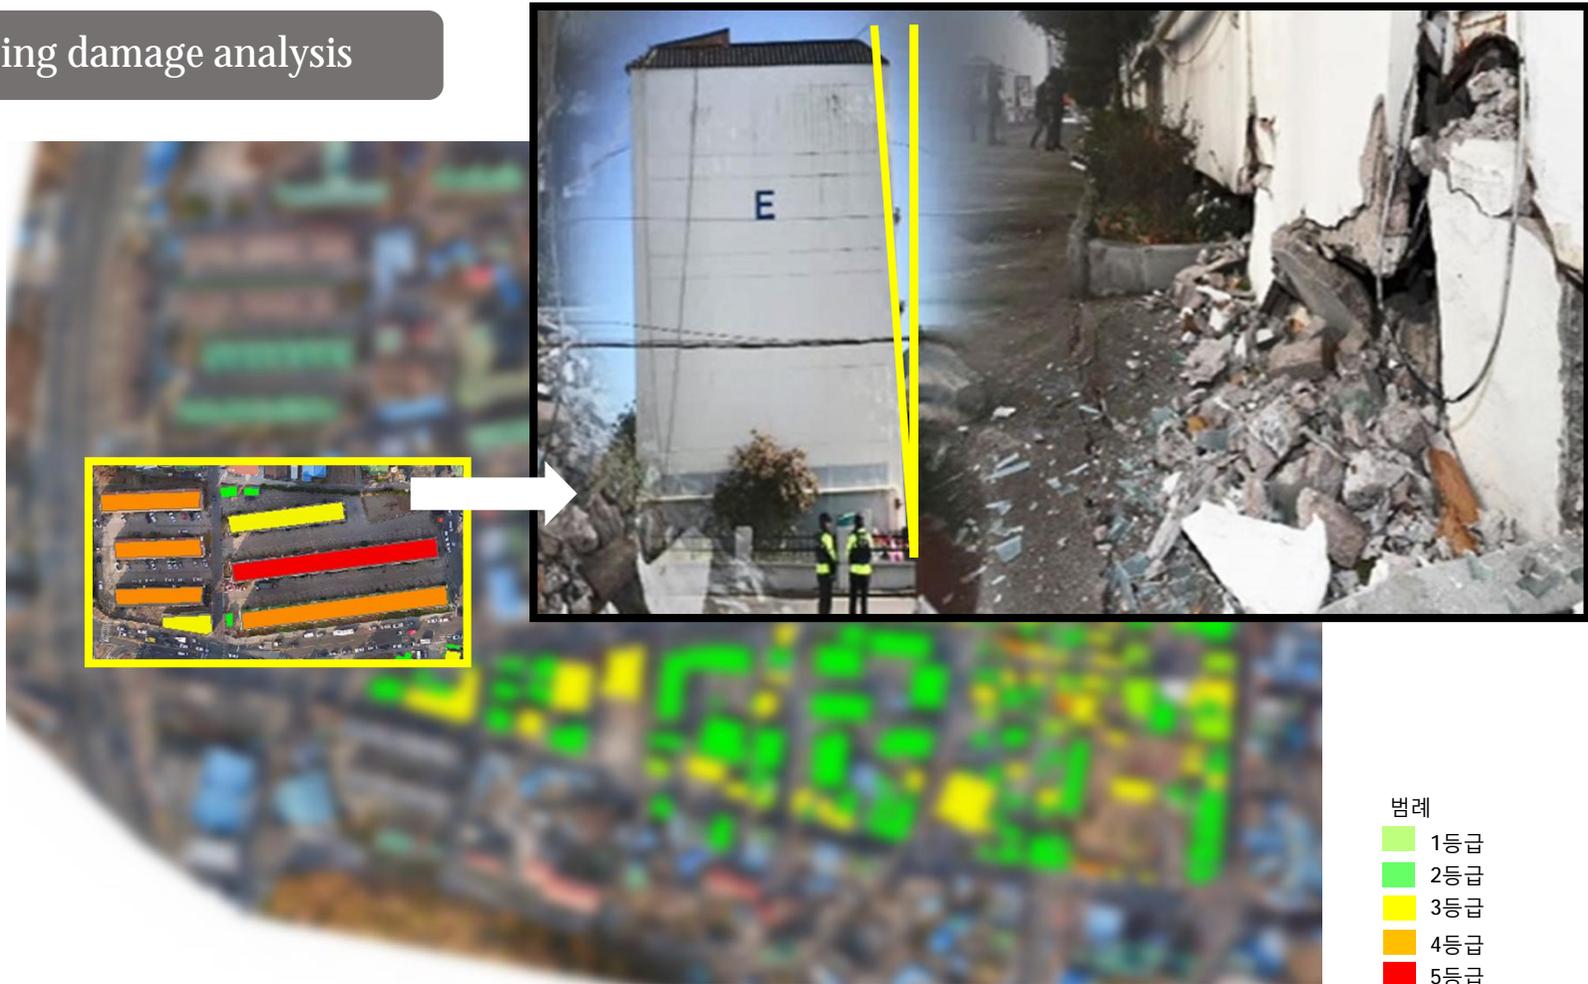
Building damage analysis

MMS(slope, well crack, damage) + UAV(well damage, roof damage)

classification about building damage
