RTS measurement of aeroelastic effects on a 30m-high historical industrial chimney

Keywords: Robotic total station; Structural Health Monitoring; Aeroelastic effects

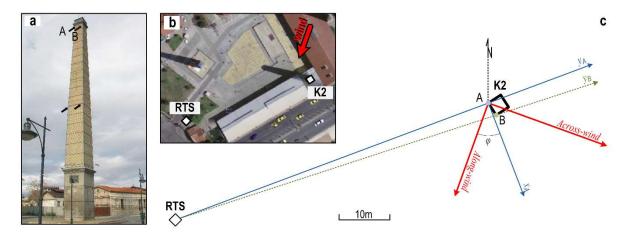
Figure 1. (a) The 30m high, 19th century industrial masonry chimney (K2) in the center of Athens. The arrows at the top indicate the position of the reflectors (A and B) that were monitored during our field survey. (b) Google map aero-photography of the study area showing K2 chimney, the location of the RTS and mean wind direction. (c) Details of the local survey coordinate system. Target A on top of K2 chimney was measured during the first three measurement intervals, and B on the 4th. Local coordinate systems for sighting targets A, B, global coordinate system and wind direction are also shown.

In this article we report the results of a survey focusing on dynamic deflections of the top of one of the three similar, 30m high, 19th century industrial masonry chimney (Fig 1a), in the center of Athens, in the Gazi area (Technopolis recreation and culture center). These chimneys are 3x3m wide at their base, apparently slender, and their excitation by wind is possible.

Our survey was made on May 30, 2005 during a period of moderate to strong wind and was based on Robotic Total Station (RTS) (or robotic theodolite, or TPS Total Positioning System) and on prismatic reflectors fixed on the top of the K2 chimney (proximal to Piraeus St.; Fig 1b).

Our survey measurements were based on a Robotic Total Station (RTS) sighting to a reflector fixed on the upper part of the studied chimney (Fig 1a). A LEICA TCA 1201 RTS, with built-in software upgraded to record measurements with a resolution of 0.01sec was used (cf. Stiros and Psimoulis 2012). The RTS was setup on a tripod on stable ground, near the main entrance of the Gazi complex, approximately 65m from chimney K2 (nearest to Piraeus Street), in a site somewhat protected from wind. The selected setup point permitted also undisturbed view to two prismatic reflectors (A, B) fixed on the same face of chimney K2, near its top. Reflector A was sighted during the first three survey intervals, and B during a fourth interval. For all four intervals, the RTS center and the mean coordinate of the reflector were used to define local cartesian coordinate systems, and to record instantaneous coordinates of the sighted reflector.

For each survey interval, from the recorded data describing instantaneous positioning of the observed reflector, a mean value of the coordinates of the reflector was computed, and the axes of the local coordinate system were correlated with true North (Fig 1c). Then, for all four intervals, time series of instantaneous deflections of the reflector from its mean value were computed. For each interval, time series of instantaneous deflections (x, y) relative to the mean coordinate of each interval, became hence available. These deflections refer to local coordinate systems (Fig 1c, Table 1).

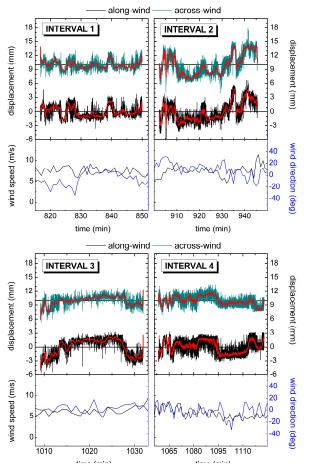
Figure 2. Along and across-wind deflections of the chimney and wind characteristics (black line indicate velocity, blue line deviation from mean direction). A red line indicates the longperiod displacement of the top of the chimney. Deflections are significant both concerning the across-wind and the alongwind component.

Results for each of the four intervals are plotted in Fig 2, so that a possible relationship between the two components of deflections and wind velocity and direction can be derived. Deflections were also plotted in the hodographs of Fig 3, in which the mean direction of wind was also shown.

that the relative dislocations of Fig 2 are significant, and they reflect "true" deflections because of the excitation of the chimney by the wind, both in the across-wind and the along-wind components.

Another main result is derived from both Figures 2 and 3. Fig 2 shows that apart from a component of deflection along the wind, there exists a component normal to the wind as well (cf. Table 1). Fig 3 shows that the across-wind component tends to be higher than the along wind especially during the 2nd and 3rd interval. This is expected and is likely to correspond to Karman street vortex effects which have been well-documented in various modern tall, slender structures usually made of concrete and steel (Bachmann et al, 1977; Holmes, 2015). However, because of the low sampling rate of the wind (1 measurement per 60seconds) and the relatively low sampling rate of the RTS (2Hz), no details of the characteristics of these aeroelastic effects are possible.
