Introduction

Digital Close Range Photogrammetry

- This study documented Afyonkarahisar Mevlevi Lodge using the digital close range photogrammetry.
- Façade plans producing by the means of digital close range ⁴ photogrammetry.

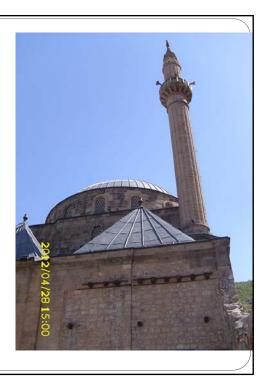
- Another important cultural heritage is the Afyonkarahisar Mevlevi Lodge.
- It served as the base of our study.
- It was a religious complex.
- Built in 1710, Afyonkarahisar Mevlevi Lodge is used today as a mosque and museum.

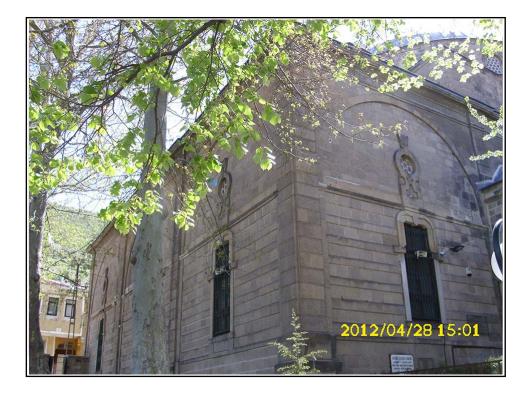
Used Data and Methodology A local network covering Afyonkarahisar Mevlevi lodge is created to measure the ground control points. 139 Ground control point selected on surface of Mevlevi lodge was measured. Ground control points were measured by using reflector less total station South NTS-352R. Measurement accuracy is ±(2 mm+2 ppm) The images are taken with Samsung S730 digital camera. Is a non-metric camera. Calibrated by using Photomodeler software.
