Static and dynamic measurements of the historic wooden church building in Domachowo

Ireneusz WYCZAŁEK, Piotr MARCINIAK and Zdzisław PAWLAK, Poland

FIG Congress 2022
Volunteering for the future - Geospatial excellence for a better living
Warsaw, Poland, 11–15 September 2022

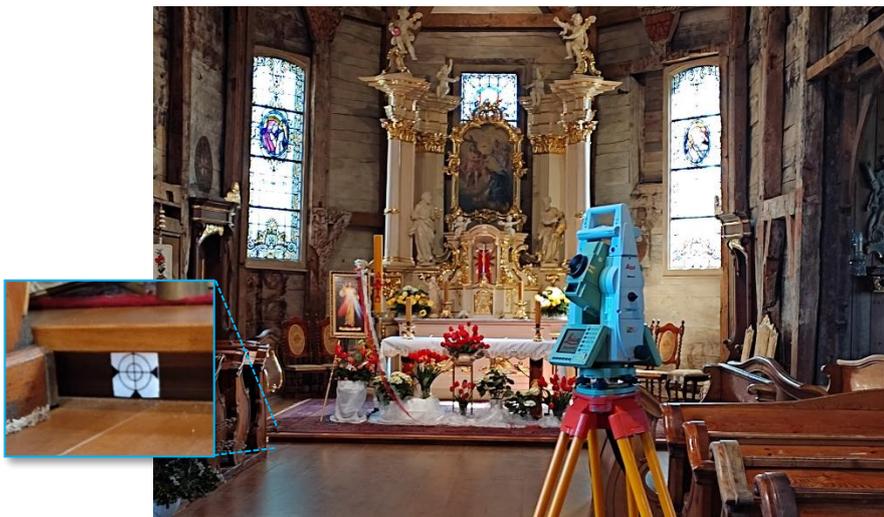
Fig.5. Leica TCRP 1201+ total station in the station in the center of the nave; on the left side, a reflective foil target – one of the points of reference.

The basis of the static measurement is the tachymetric method – it was carried out with the use of a 1-second Leica TCRP 1201+ total station and targets in the form of reflective foil targets (Fig. 5) – no prisms were used to ensure discretion of the measurement on an intensively operated object. Based on previous experience, it was estimated that for distances up to 10 m and vertical angles up to 40° , all coordinates can be determined with the mean error of a single measurement ± 1.0 mm and the error of the mean of 4 readings ± 0.5 mm. The results of 15 double series of measurements showed discrepancies between the series in the range of -1 mm to $+1$ mm, with the most common values in the range of ± 0.2 mm (Table 1). The sights are located 6.45–6.85 m above the floor level, while the ceiling rises to a height of just over 7 m. The height of 7.0 m is considered to be representative of the level for which the displacements are calculated. It was decided to control both the movement horizontally (u_x , u_y) and vertically (u_z), but in order to avoid the results caused by subsidence of the foundations, as well as possible shrinkage and expansion of the structure, in addition, vertical displacements on the columns just above the floor are measured (points 11 and 12 in Fig. 3).
