Wendouree Power Station Remediation*.

Former Wendouree Power Station, Ballarat, Victoria.

Project name: Wendouree Power Station, Ballarat, Victoria*

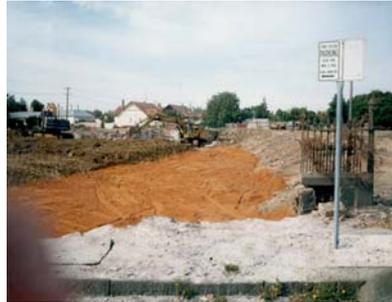
Backfilling operations showing the orange marker layer above the contaminated soil capsule.

In consultation with the site Auditor, a cost effective solution was developed to encapsulate the contaminated soil in the basement area, beneath the proposed roadway for the residential subdivision. The soils were encapsulated within the basement floor and walls and a marker layer of artificially coloured sand was placed on top to mark the upper extent of the contaminated soil (see photo – top left). The contaminated soil was placed to a minimum depth below the road surface to minimise potential health effects from contaminants.

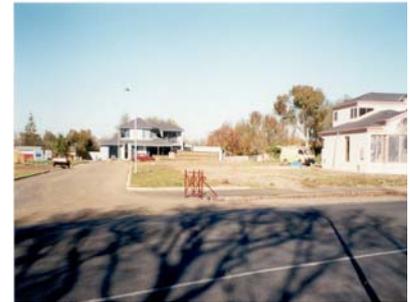
Finished product – Residential development. Contaminated soil capsule is beneath roadway.

The site has now been developed as an exclusive residential estate in a prime lakeside environment (see photo – top right).
