Building Damage Detection to the 2008 Wenchuan Earthquake by Fusing the High-resolution SAR and Optical Images

KEY WORDS: Synthetic Aperture Radar (SAR), Correlation, Seismic damage assessment, Wenchuan Earthquake

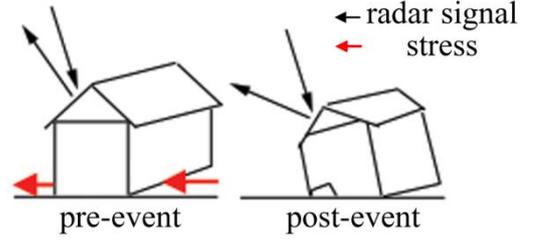
Figure 1. Leaning of scattering interface. The building would change the shape of the roof, which makes the radar signal change the backscattering direction.

1) The surface shape change causes the scattering path to change (Fig. 1, Fig. 2). As the angle of the building roof changes, or nearby objects form new parts of the building, the backscattering signal changes its direction and intensity.

2) Leaning. Specular reflection happens on flat roofs and produces a weak backscattering. So the correlation would decrease when the corresponding building leans, such as case 4 (Fig. 13), the Qushan School, which is a typical example of condition 1 (Fig. 1). But this condition is easily mistaken with surroundings noise. The result needed to be verified by other data, such as LiDAR.

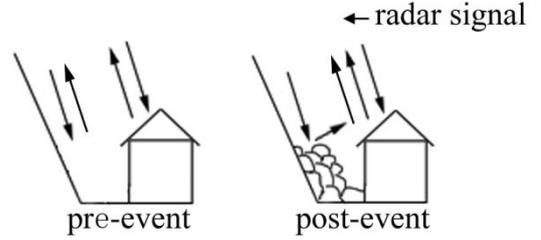
Figure 2. Expansion of scattering interface. Because of accumulation due to the landslide, the scattering intensity would increase.

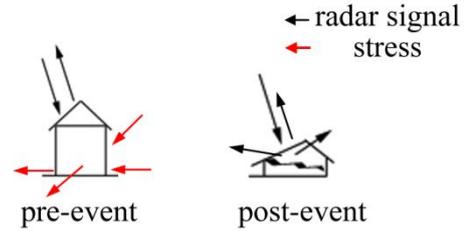
Figure 3. Building collapse. The surface backscattering is transformed to the anomalous volume scattering.

2) Structural collapse makes single-bounce scattering change to different directions (Fig. 3). The height and structural change create a new roughness interface instead of the old flat one. So simple surface backscattering was transformed into anomalous volume scattering.

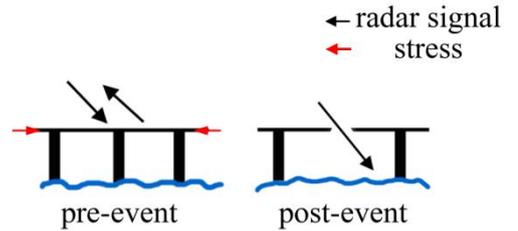
Figure 4. Broken bridge. The signal which penetrates the hole would be absorbed by the water.

3) The change of interface material transforms absorption and backscattering (Fig. 4, Fig. 5). The most common factor is water.

The narrowing of valleys related to multilayer detachment is initiated by the process of stress release and strain recovery from the fault rupture, which is a typical example of condition 3 (Fig. 4). In Fig. 15 we can observe the raised distortion of the bridge from stress.

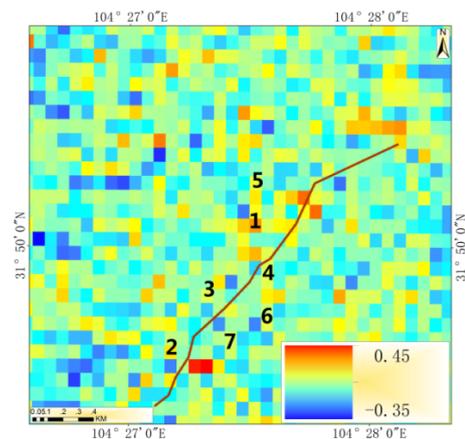
Figure 6. Result of correlation decrease. The objects are indicated by the number.

The demonstration area was former Beichuan (E104.44°~104.47°, N31.82° ~31.85°). The pixel value of the correlation image (Fig. 6) represents the decrease in the correlation coefficient. Through statistical analysis (Fig. 7), the mean value was 0.017756. So due to the earthquake, the correlation in Beichuan decreased, which accorded with the conclusion in the previous paper.

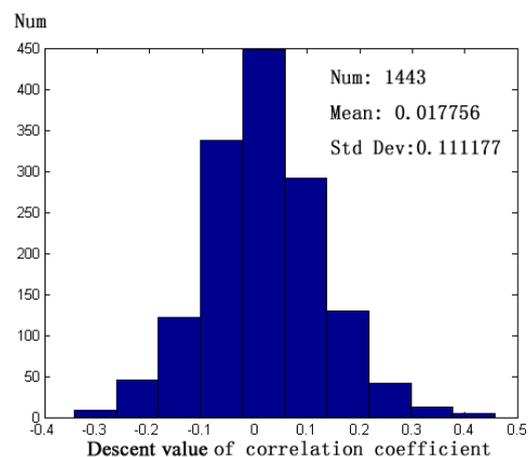
Figure 7. The statistical histogram of the pixel decorrelation value in Beichuan

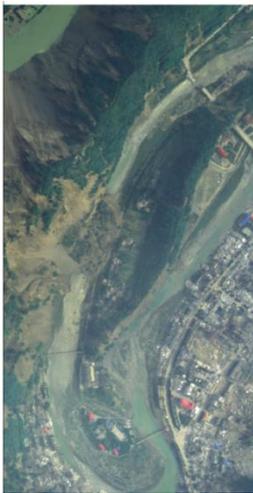
Figure8. The post-earthquake aero optical image.

The open air museum of the Wenchuan earthquake ruins in Beichuan provided us the opportunity to investigate the relationship between the theoretical result and the degree of damage. In order to get the corresponding objects, edge vectors, which was extracted from high resolution aero optical images (Fig 8) by Objected-Oriented classification, was overlapped to the correlation image (Fig 9). The accuracy of the proposed method was validated by comparing the result of calculation with the ground investigation. Some pixels are listed in Table 2. As the defective error in general, the data values were normalized and only used to see the deformation trend. The objects were classified into two classes: direct damage and secondary damage.

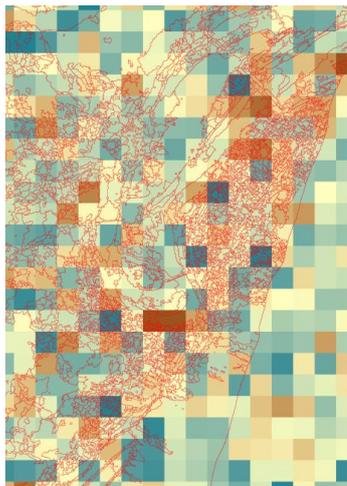
Figure9. The object-vectors extracted from the aero

optical image.

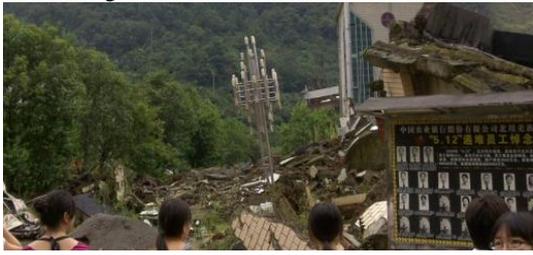
Figure10. Case 1. Collapsed buildings. Before the earthquake this was the Agriculture Bank of China, Beichuan Sub-branch.

1) Collapse. This heaviest damage pattern was mainly found near the fault rupture, such as case 1 (Fig. 10) and case 2 (Fig. 11). The corresponding pixels had the most-decreased correlation coefficient values in our cases: 0.314575, 0.218009 (Table 2). This indicated that the open spaces or collapsed buildings had rather lower reflectance because microwaves are scattered in different directions, which are typical examples of condition 2, leaning (Fig. 3). An interesting case was case 3 (Fig. 12). Only the first floor of the damaged building collapsed, while the higher floors still kept their surface shape. This condition was very hard to be identified through the pre-earthquake optical images because of the view angle. Although the change value of 0.126538 was not as high as other collapsed buildings', such as cases 1 and 2 (Table 2), the value was high enough to recognize the damage from the surrounding pixels.

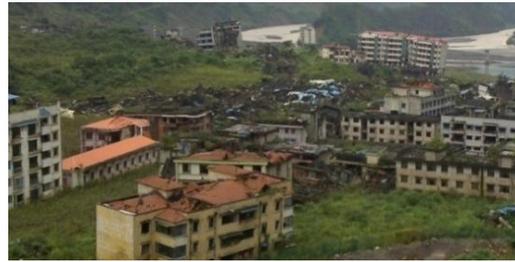
Figure11. Case 2. Collapse of building groups in the south of the town.

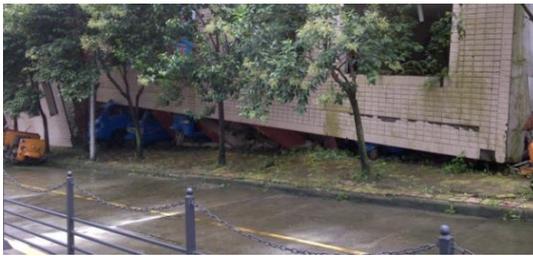
Figure12. Case 3. The first floor of the building collapsed in the earthquake, but the higher floors still kept their surface shape.

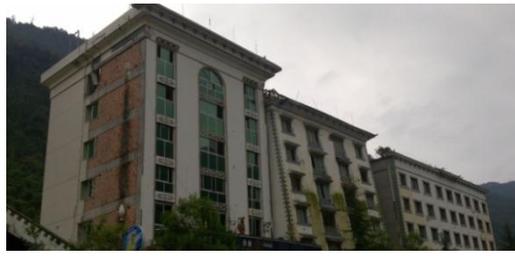
Figure13. Case 4. Leaning building. The building is Qushan School, which is next to the Beichuan Police Station.

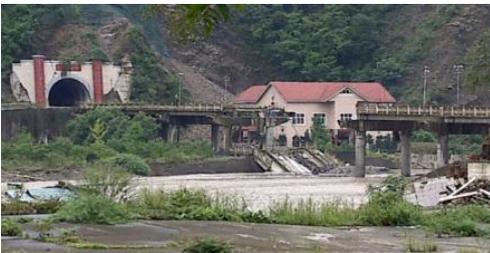
Figure14. Case 5. Xiayu Bridge, broken because of distortion from valleys.

3) Distortion. This condition usually happens along roads and bridges, such as case 5 (Fig. 14, Fig. 15).

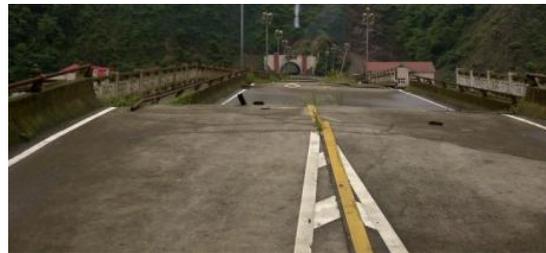
Figure15. Case 5. Xiayu Bridge, broken because of distortion from valleys.

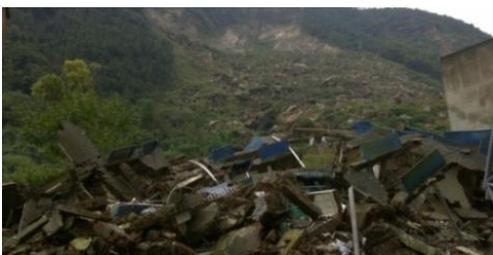
Figure16. Case 6. Xiayu Bridge, broken because of distortion from valleys.

1) Landslide. Double bounce reflection happens between building walls and the ground, which produces a strong backscattering. So the correlation coefficient would be reduced as the irregularity of the ground surface changed due to landslides and slope failures, such as case 6 (Fig. 16), which is happen near a mountain edge area.

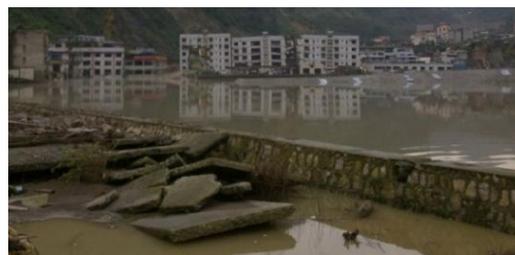
Figure17. Case 7. Landslide near the bend of the Jianjiang in the town.

2) Barrier Lakes. Water absorbs microwaves, which makes corresponding pixel values decrease, such as case 7 (Fig. 17), a typical example of condition 3 (Fig. 5). This condition should be validated by river vectors and optical images, as penetrative
