Multibeam and sidescan sonar application for determining the position and shape of the remains of Hadrian bridge on Drava river

Branko KORDIĆ, Croatia, Almin ĐAPO, Croatia, Boško PRIBIČEVIĆ, Croatia

Key words: Hadrian bridge, hydrography, multibeam, side-scan sonar, Drava river

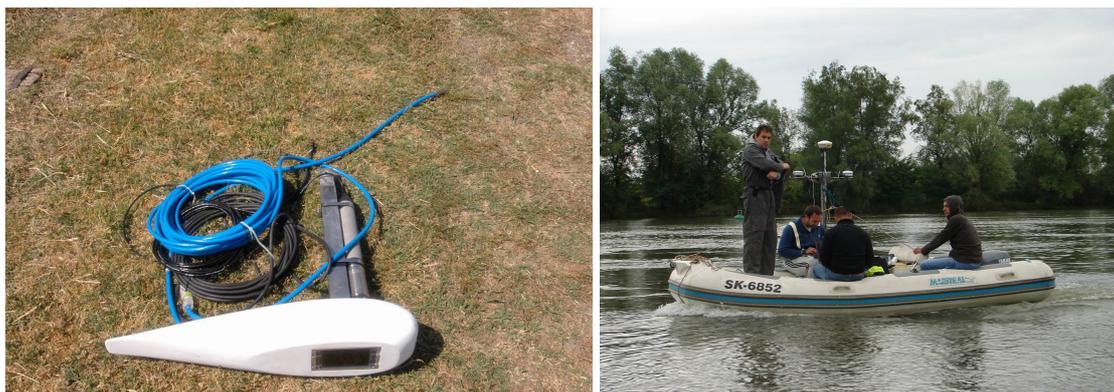
Figure 1. Multibeam echosounder and a vessel on which the system was installed

For the purpose of data collection multibeam echosounder ES3M Odom with TSS DMS 25 motion sensor and heading sensor 100 Hemisphere was used, and as mentioned above, Trimble R8 RTK was used as a positioning device. The main characteristics of this system are the compactness and functionality that allow it to be installed on a small boat. This is made possible by setting up complete system on a common adapter, which allowed removing the error of determining the offset between the individual sensors. However, it is important to mention limitations of the system that occur due to the accuracy of individual sensors and the instability of the platform (the size of boat). As already mentioned, the main problem for conducting the measurements are strong river currents that make it difficult to maintain the direction of the planned survey lines, especially heading error and roll and pitch error.

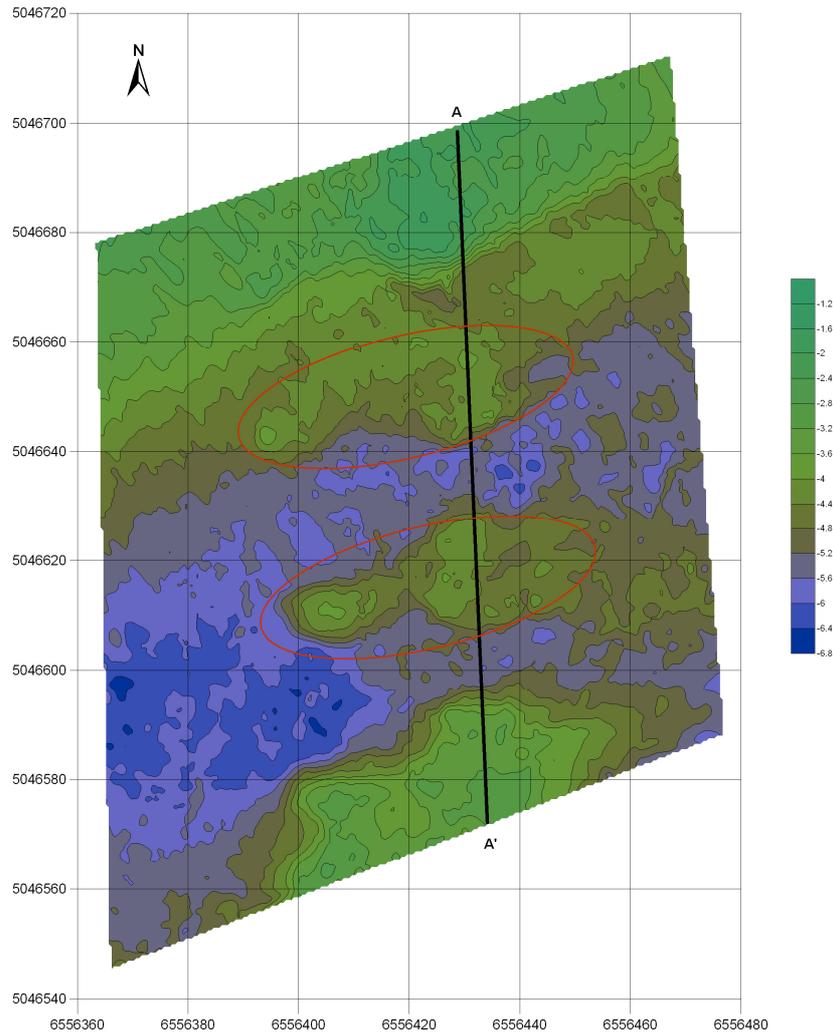
Figure 2. Bathymetric map showing the remains of the pillars of the Hadrian bridge

Analysis of the data was conducted using HypackMax-Hysweep software. Processed and cleaned data was exported and the bathymetric map was created using Golden Surfer software. The part of the bathymetric map showing remains of the pillars of the Hadrian bridge on river Drava is shown on figure 2, and the longitudinal profile AA' is shown on the figure 3. Span between the pillars can be roughly determined to about 25-30 m which is the distance mentioned in the historic documents.
