# 3D Laser Scanning for Masonry Arch Bridges

Thomas WERNER and David MORRIS, Australia

**Key words:** Bridge surveying; Deformation measurement; Engineering survey; History; Laser scanning; Risk Management

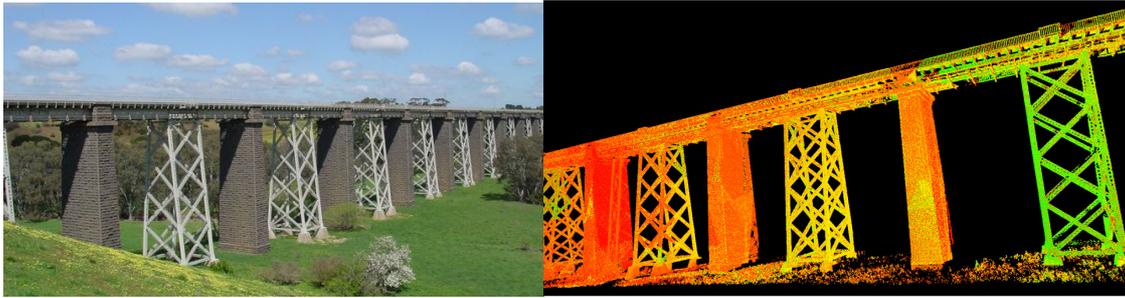
**Fig 2: Moorabool Viaduct image and laser scan point cloud.**

3D laser scanning can be used as a cost effective method of surveying heritage steel railway viaducts (see Fig 2.) to produce as-constructed drawings. Whereas traditional survey methods required either the installation of extensive access platforms or specialist roped access, laser scanning surveying has the ability to safely and remotely acquire information without direct contact.

The height of the steel lattice towers alone presented serious OH&S problems, which were completely eliminated by the use of the 3D laser scanning technique.

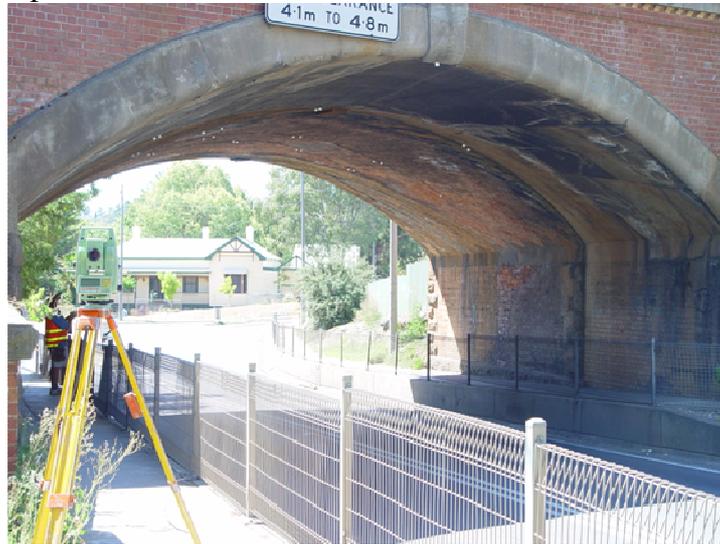
**Fig 8: Traditional survey method using targets.**

Traditional methods of surveying arches (see Fig 8.) rely on the application of targets which are monitored for movement. Only the targets are observed for movement, which practically limits the number of points that can be monitored.

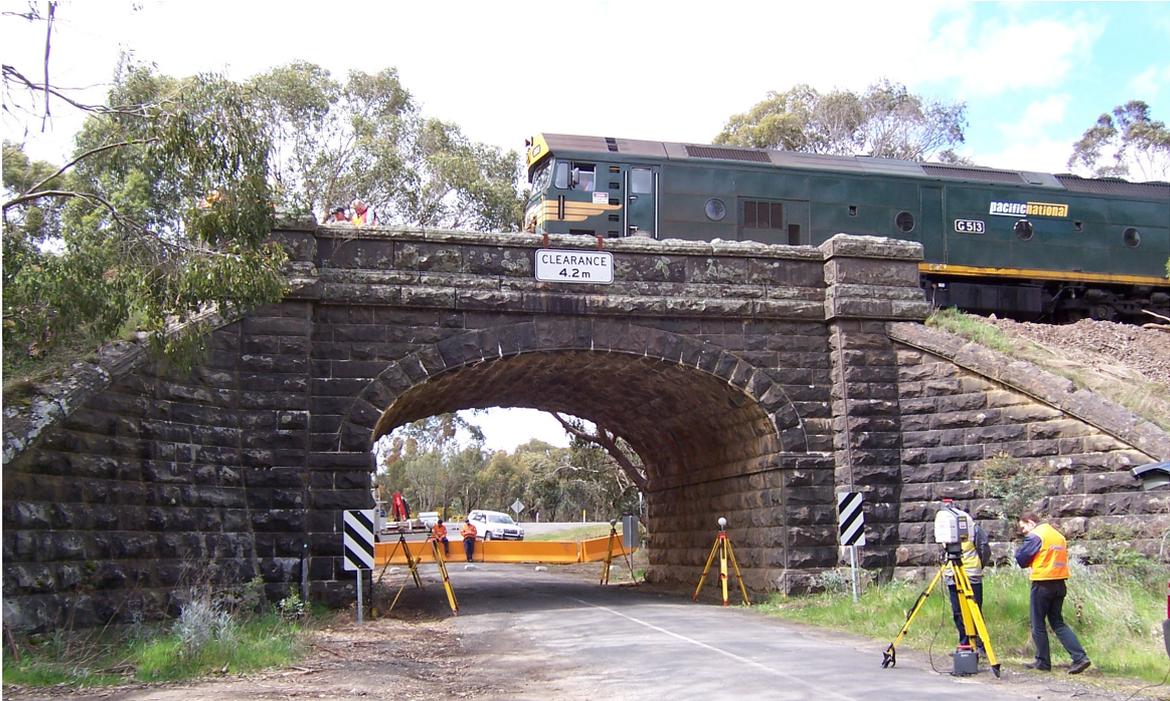
**Fig 10: Load test on blue stone bridge.**

The changes in shape of the Blue Bridge arch were detected by scanning the arch surface under no load, and then with the locomotive at the most adverse position (see Fig 10.). By comparing the two scan results for the arch (see Fig. 7); it could be observed that the arch moved noticeably under live load.

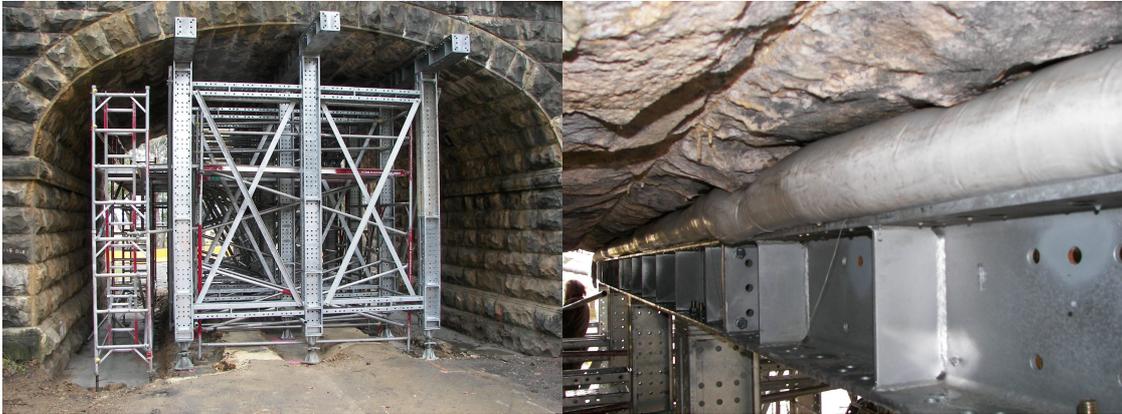
**Fig 13: Propping using proprietary false-work and grout bags.**

Following the load test on the bridge revealing deformation in the arch under load, the bridge was propped (see Fig 12.) as a temporary measure whilst a permanent solution was discussed with Heritage Victoria.

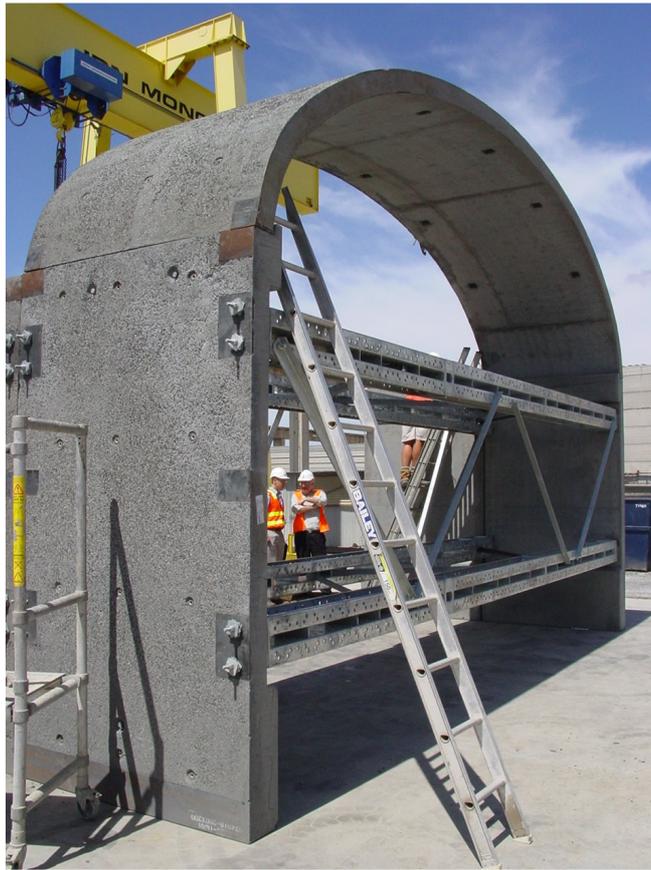
**Fig 15: Trial assembly of the precast concrete liner.**

The solution developed by GHD involved the detailing of a precast concrete liner, which was assembled on site and pushed into position under the blue stone bridge. The shape of the blue stone arch was accurately determined from 3D Laser Scanning data initially acquired and was used to detail the shape of a precast concrete liner (see Fig 14 & 15.).

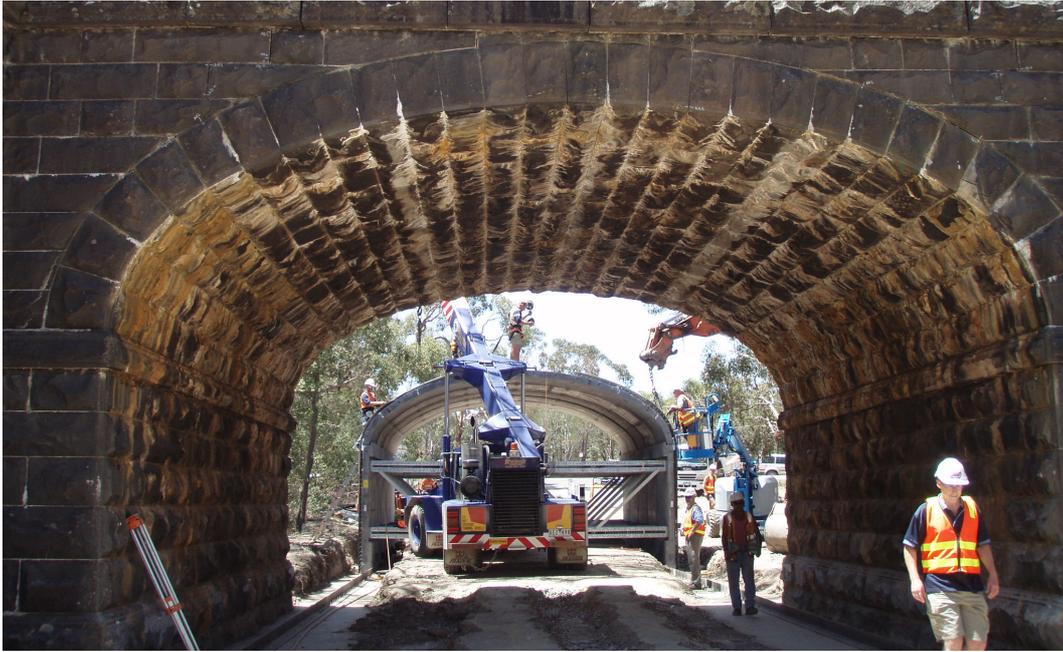
**Figure 16: Precast concrete liner ready for sliding (with reo attached).**

The gap between the liner and the blue stone was to be filled with self-compacting concrete. In addition the strengthening was designed to resist loads which may result from long term spreading of the original abutments. This required the gap between the precast arch and the blue stone to be wider at the ‘shoulders’ of the arch, and additional reinforcing bars were added to this section. Heritage Victoria’s requirement for a fully reversible solution was met by applying a bond breaker to the surface of the arch before strengthening work commenced. The complete precast concrete arch (with reo attached) was assembled on a sliding track adjacent to the bridge (see Fig 16.).

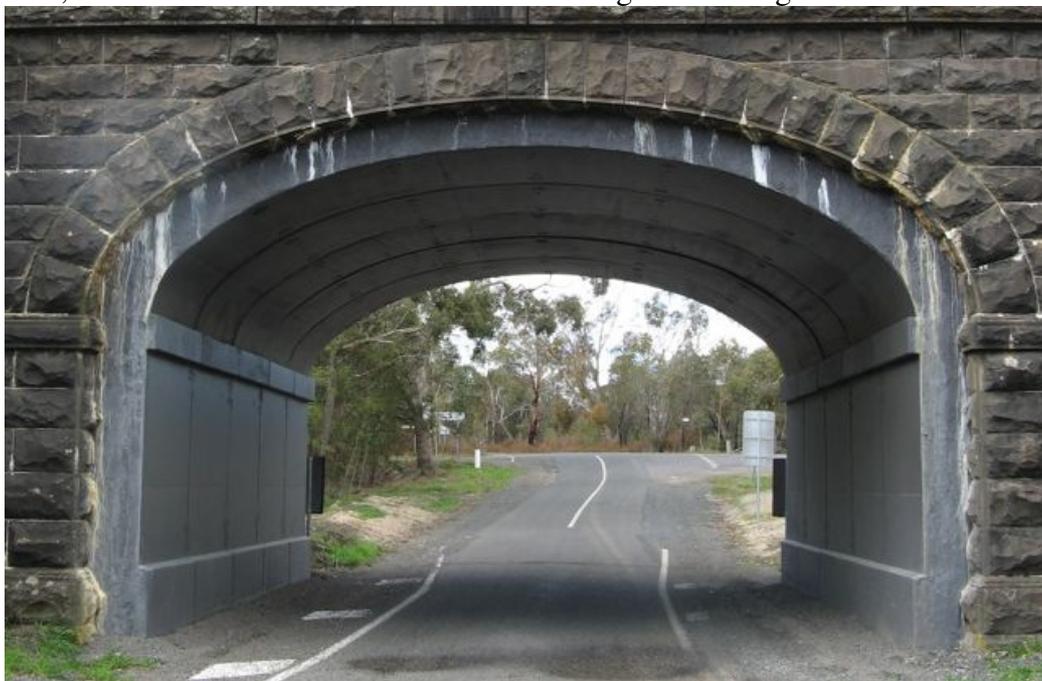
**Fig 17: Completed strengthening works.**

The completed project (see Fig 17.) provided the required strengthening with a well engineered, well detailed solution which did not damage the heritage structure.
