Re-establishment of Cadastral Boundaries Following the 2010 Earthquake in Canterbury, New Zealand

Mark SMITH, Mack THOMPSON, Nic DONNELLY and Don GRANT, New Zealand

This paper describes the effects of the earthquake on cadastral boundaries in the region. It then discusses the steps that are being taken to provide certainty in cadastral boundary re-establishment by surveyors.

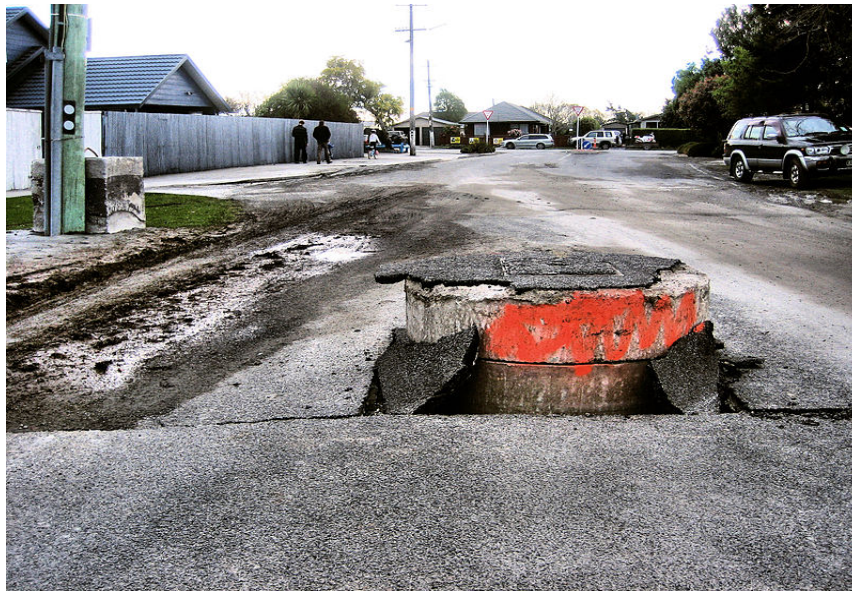
Figure 2 illustrates the extrusion of a stormwater manhole structure through the road surface due to the effect of liquefaction.

Figure 2 – A stormwater manhole raised by liquefaction (Photo from Wikipedia)

Most surveying reference marks are placed within the road corridors of the city, and where the road surfaces were disturbed by liquefaction, these marks were moved from their original positions.

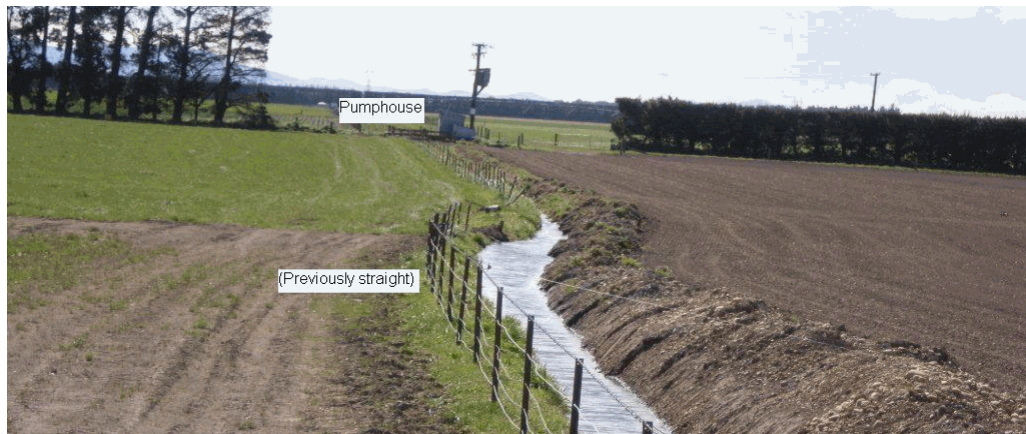
Parcels of land astride the 24 kilometre long fault line were offset in places by up to 4 metres. Fences, water races and road formations clearly show the extent of the offset.

The surface fault rift passes through approximately fifty separate cadastral land parcels in a rural area used primarily for agriculture and horticulture.

Figure 3 – Effects of fault rupture on previously straight fence and water race (Photo Survus Consultants)

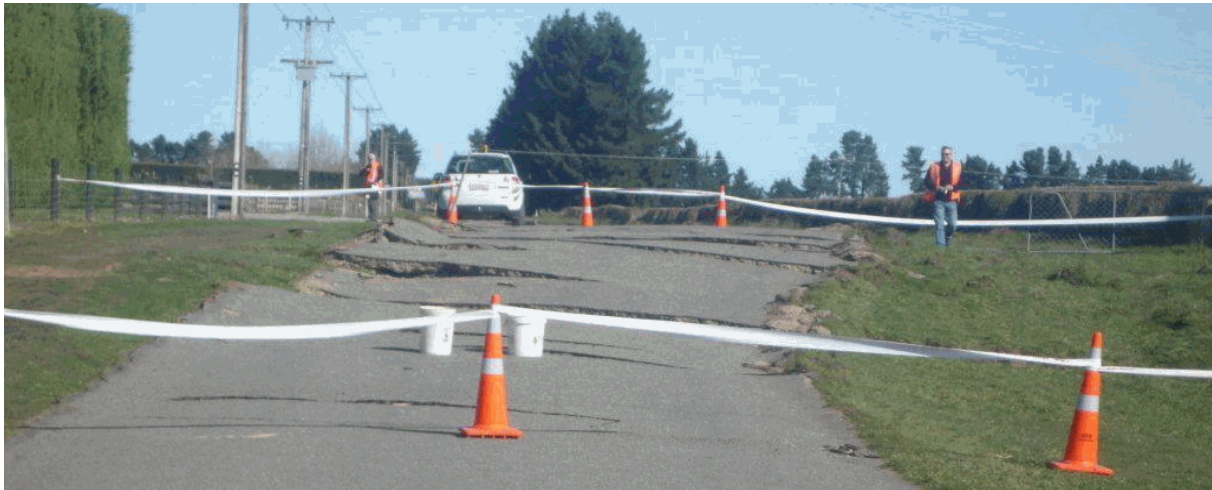
The differential movement on either side of the fault is principally horizontal with local areas of vertical movement.

Figure 4 – Effects of fault rupture – previously straight road (Photo Survus Consultants)

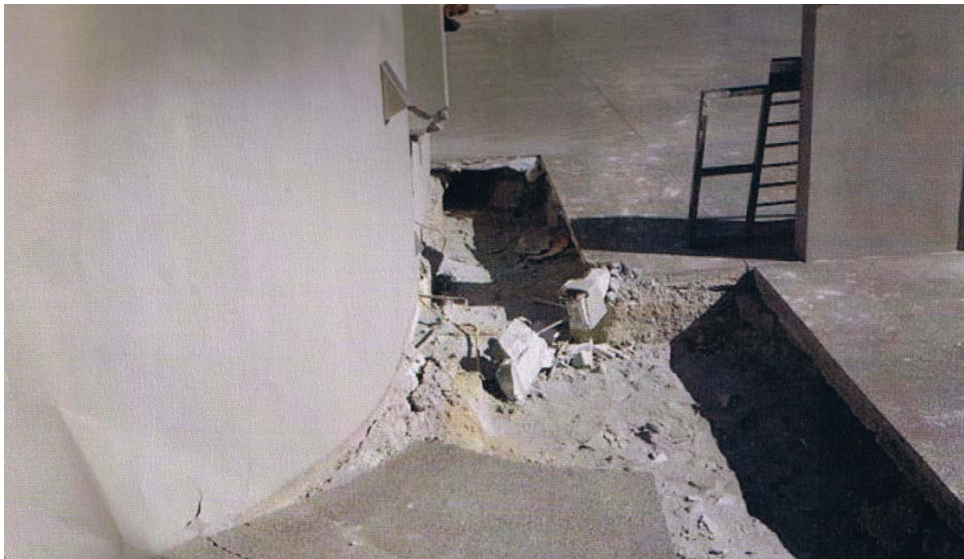
Figure 5 is an example of the rifts created between buildings and paving which were originally adjacent. In the case of wooden framed buildings on masonry foundations, the foundations often split and moved out from beneath the wooden framing.

Figure 5 – Displacement due to liquefaction (Photo from Eliot Sinclair and Partners)

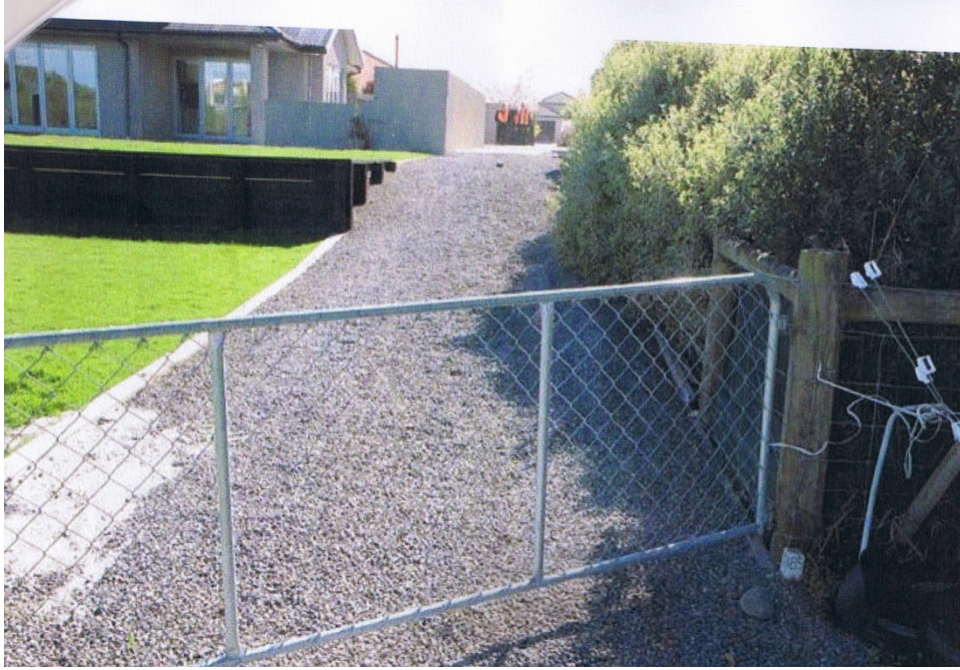
In two suburbs adjacent to wetlands extensive shallow surface movement (lateral spreading) took place towards the water body. Figure 6 is a photograph of a gate at the rear of a property giving access to a riverside recreation area. The white peg at the base of the post is a legal boundary monument. These features appear undisturbed yet after the earthquake they had moved 2.8 metres away from the roadside which was only 80 metres away.

Figure 6 – Boundary point has moved 2.8 metres due to lateral spreading as a result of liquefaction
(Photo from Eliot Sinclair and Partners)

New Zealand has no prescriptive law or regulation for the re-establishment of boundaries following earthquakes or landslip. There is also a lack of common law to assist surveyors with precedents for re-establishing boundaries following an earthquake. Moreover, the movement experienced following the Darfield earthquake causes difficulty with the hierarchy of evidence when a boundary monument may appear undisturbed from its originally placed position but has moved considerably. See Figure 6 above.
