# Innovation from Disaster - Applying 3D Laser Scanning Technology to Earthquake Recovery Projects

Andrew SINCLAIR, New Zealand

FIG Working Week 2016  
Recovery from Disaster  
Christchurch, New Zealand, May 2–6, 2016

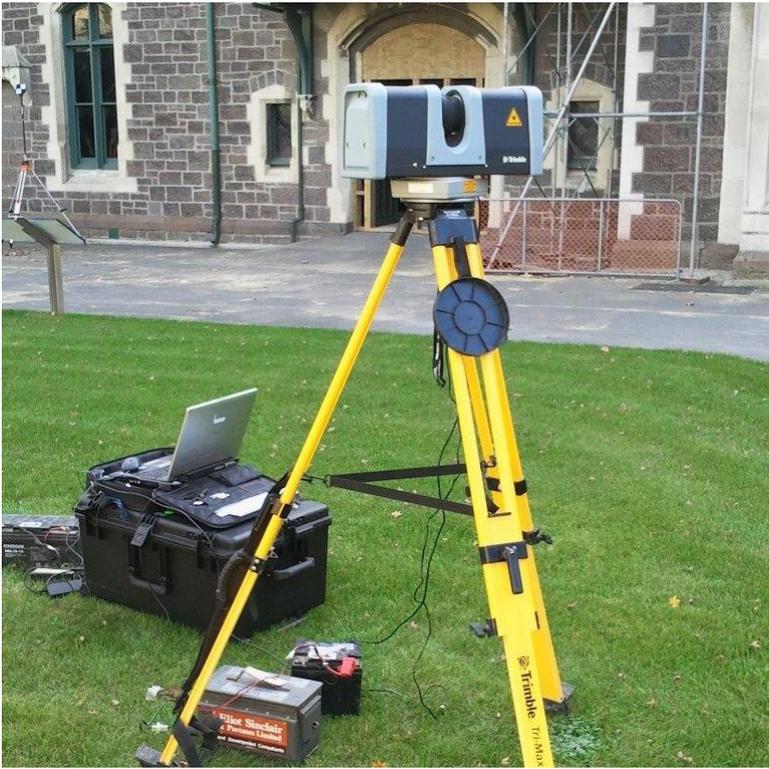
**Figure 2 - Trimble FX Scanner (2011)**

- An exciting new tool to master
- New computer software/ hardware required to handle very intensive processing and large datasets
- A need for robust quality control in the field and office
- Big learning curve
- Now in 2016 we operate 3 scanners and a Quad-copter
- Focus on geospatial framework for repair and rebuild

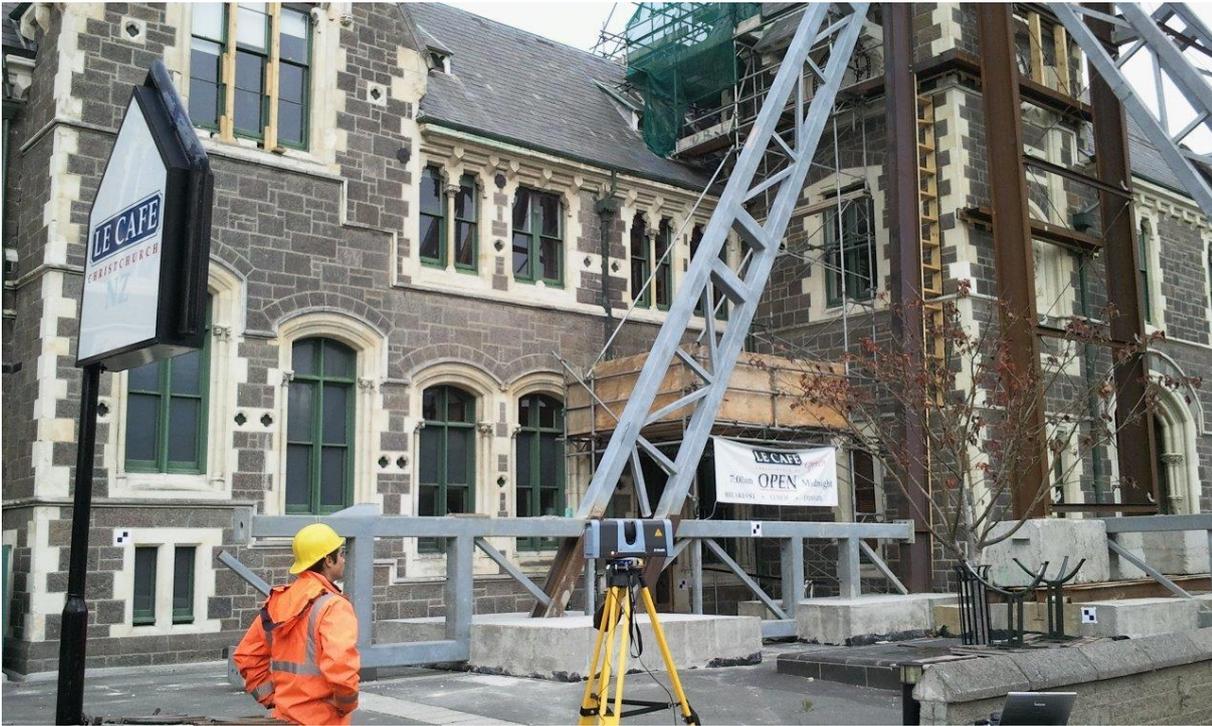
**Figure 3 - Historic Arts Centre**

- Providing data to project team of modellers, engineers, architects.
- Capability to gather millimetre accurate 3D model of existing damage
- Temporary steel structures established for continuing quakes
- Individual stones could be modelled, taken down and labelled
- The structure repaired, stones put back in original pattern
- Project is now half way to completion
- We have had repeat visits to collect extra details as needed, and to provide setting out in the project coordinate system

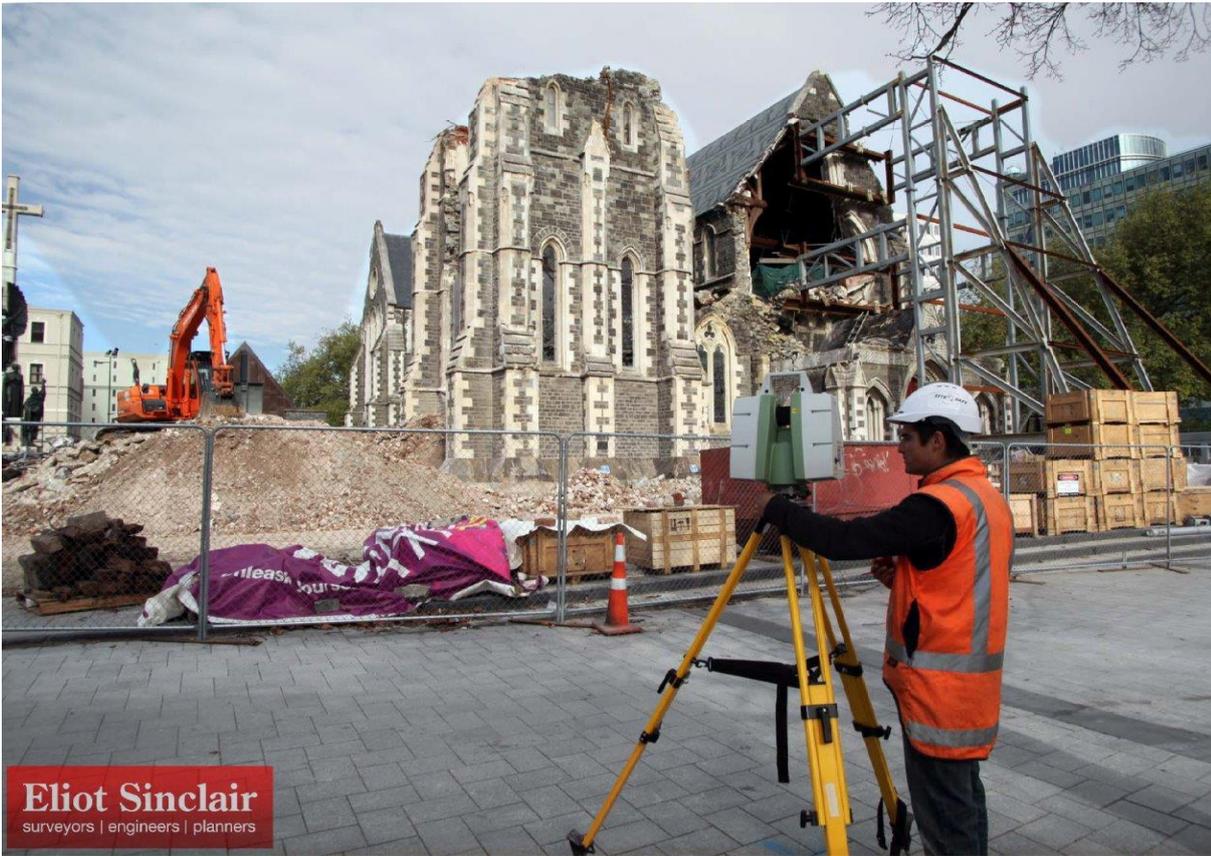
**Figure 4 - Christ Church Cathedral (Rose Window Collapsed)**

- Scanned to form a dataset for heritage purposes
- After Feb 2011 quake had destroyed rose window
- Structural damage – health and safety limited time inside

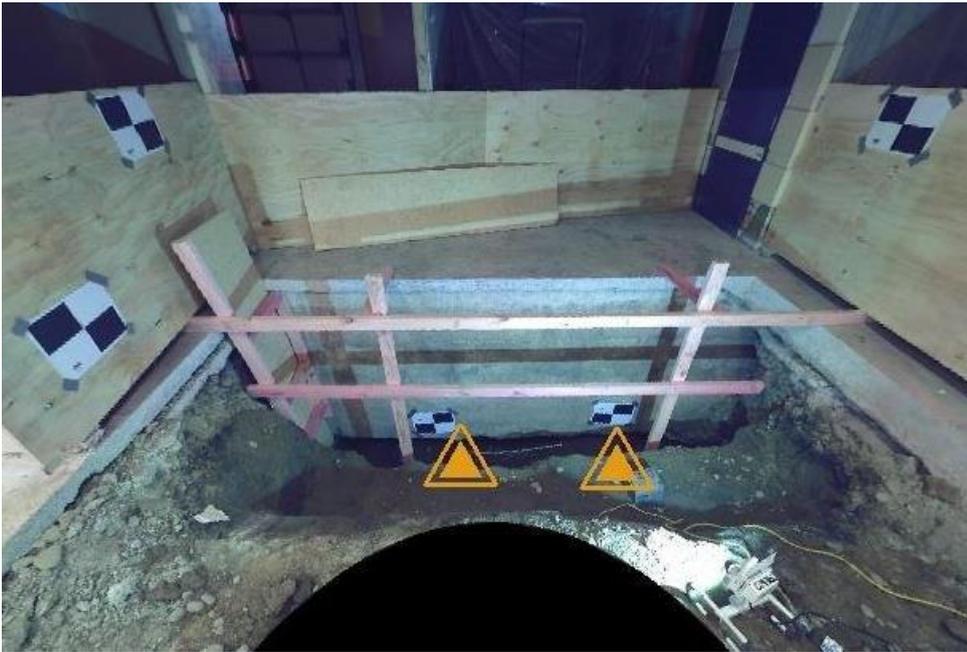
**Figure 8 - Pier Cap and Pile Location Survey**

- As part of a structural assessment, our client needed to drill through the centre of existing concrete piles, invisible beneath a pier cap.
- A portion of the sides of the piles were exposed by hand digging
- We set up our scanner below ground level and scanned the visible pile surfaces
- Control was incorporated above ground
- We modelled the piles and returned the next day to set out the calculated pile centres on top of the pier cap

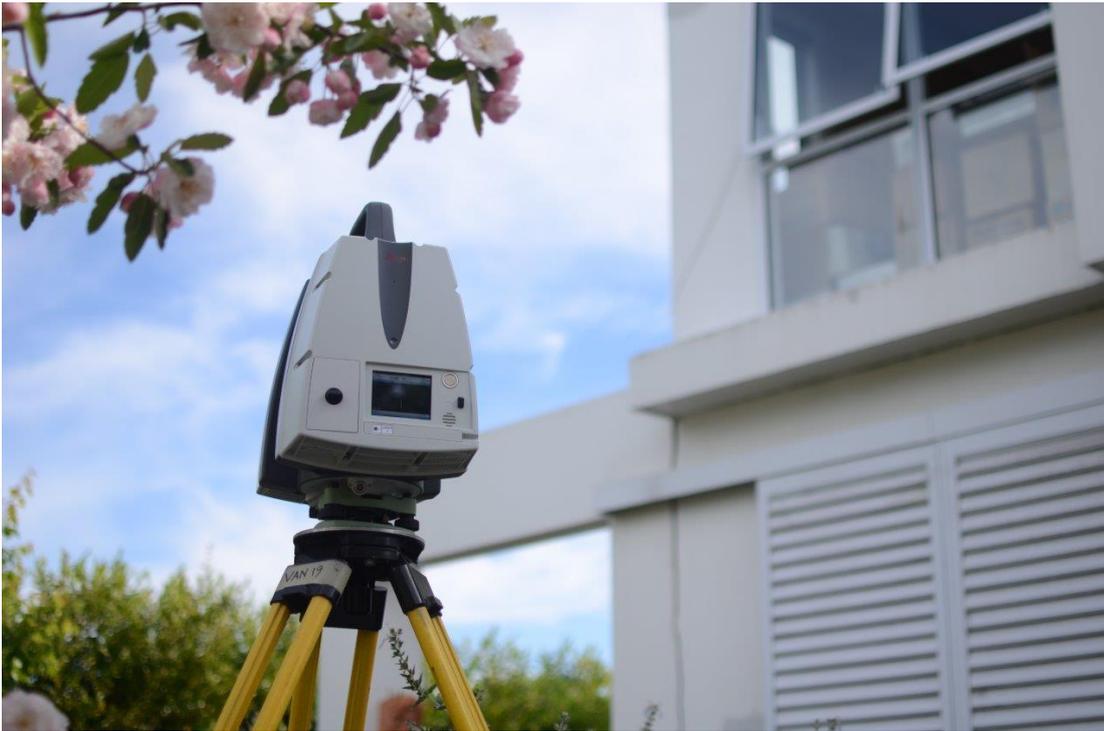
**Figure 10 - Leica P40 Scanner (2015)**

- Scanning is a technology that has become very affordable and accessible – not just for surveyors and spatial professionals
- Manufacturers have focussed on providing a simple solution that is capable of being operated by any untrained person to deliver a highly accurate and dense point cloud
- We have seen equipment failures and environmental limitations
- Field and office techniques including types of targets, target geometry and registration methodology will all influence the quality of results
- To ensure data integrity in projects with no room for error, a geospatial specialist is required to employ robust quality assurance
