Brisbane, Ast a 6–10 April

Armin Agha Karimi and Kyran Cook

Background

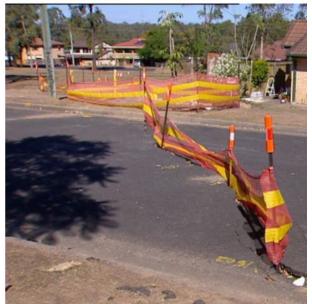
Sinkhole swallows part of Ipswich backyard; abandoned mine may be to blame

Water was sloshing around inside the huge backyard sinkhole. (ABC News: Ellie Sibson)

Homes at Collingwood Park, near Ipswich, were damaged by subsidence in April last yea

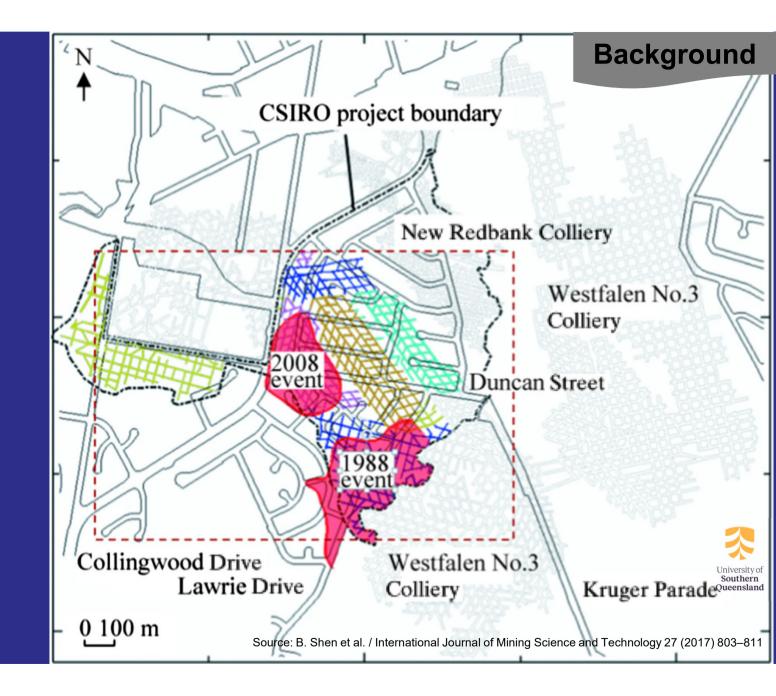
Subsidence cases

- Bord and Pilar mining at depths from approximately 60m to 140m.
- Both subsidence events occurred as a result of pillar failure
- CSIRO project:
 - Numerical modelling
 - Monitoring system combining a micro-seismic network
 - ☐ A range of remediation options was investigated.
