Deformation Measurement of Railway Bridge Abutment Pier

Otakar ŠVÁBENSKÝ and Pavel ZVĚŘINA, Czech Republic

SUMMARY

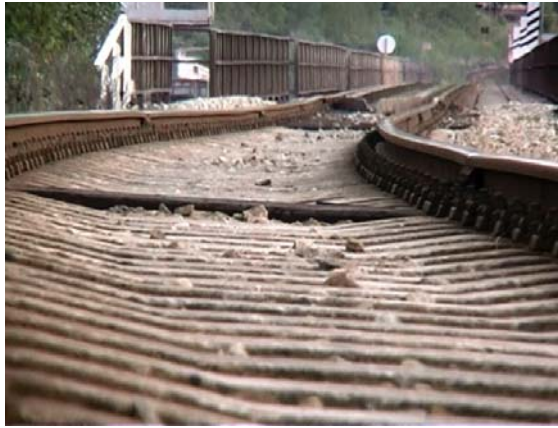
Fig. 1: Distortions of Rail Geometry

In 1978 the bridge was put to full operation. Nevertheless, the problems in stability of western end of the new bridge appeared soon after. Main problems are caused by different foundation conditions of abutments. While the eastern abutment pier is founded in solid bedrock without any functional defects, the western abutment pier shows problems from the very beginning of the viaduct operation up to the present. Adjoining earth filling is up to 23 m high here. The defects are manifested by railway track settlement and distortions of rail geometry, with frequent needs for maintenance works (Fig. 1).

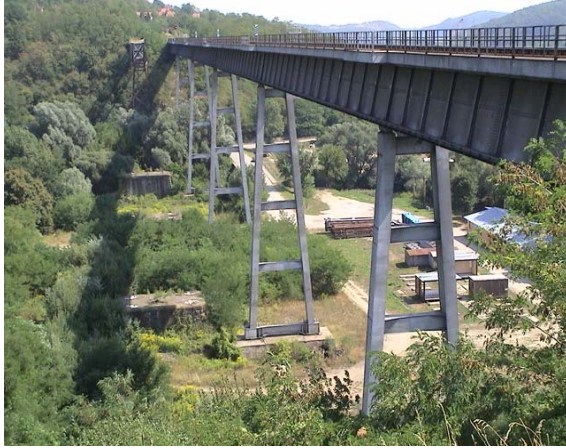
Fig. 2: View of the viaduct

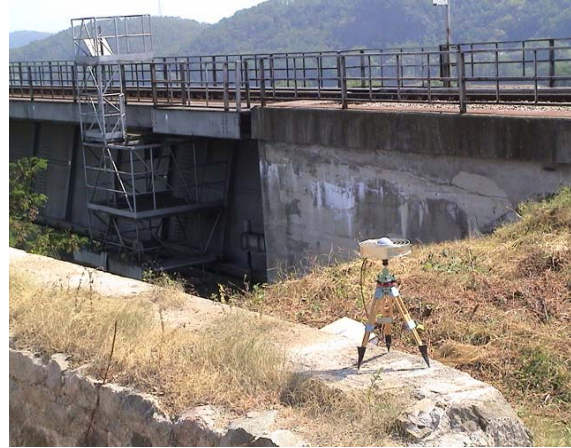
Fig. 3: Local GPS reference station SO

GPS measurements were tied to station V located on the stable eastern abutment of the old bridge in 400 m distance over the valley, and to permanent EUREF station TUBO located at Brno University of Technology in 20 km distance which operates Trimble 4700 receiver equipped with Trimble choke ring antenna (TRM29659.00). Local reference was at station SO located on western abutment of the old bridge where Leica SR399 receiver/antenna was used until end of 2003. Since 2004 the station was measured with Leica SR502 receiver equipped with AT504 choke ring antenna which is much more resistant to multipath and similar disturbing effects. Another two markers NS, NJ are located on abutment pier of the new bridge, and additional markers R1, R2 are situated at the southern side of the earth fill crest. Fig. 2 shows the view of the Ivančice viaduct from west, and Fig. 3 shows the surroundings of the local reference station SO with AT504 antenna on special short tripod for reduction of centring errors Behind is the monitored abutment pier of the new bridge.

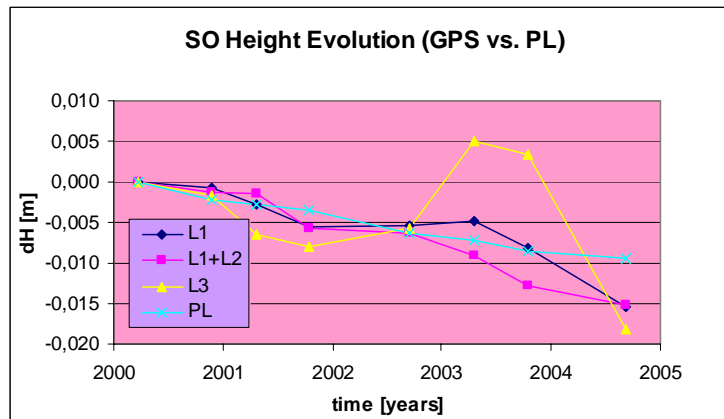
Fig. 4: Vertical displacements of station SO (GPS vs. PL)

Fig. 4 shows the time evolution in height of the reference marker SO which is situated on western abutment pier of the old bridge. Results of precise levelling and GPS (L1, L1+L2, L3) solutions are compared. GPS heights were determined in respect to reference marker V in 400 m distance situated on the other end of the bridge. Differences between commercial and scientific software results were negligible in this case. Best results gave L1+L2 processing, L1 results were almost on the same accuracy level. L3 results were of significantly lower accuracy here what was caused by practical elimination of the ionosphere effect for neighbouring stations, and by higher noise level on L3 frequency combination.
