Recurring Mass Movements on the Danube's Bank at Dunaszekcső (Hungary) Observed by Geodetic Methods

KEY WORDS: Landslide, GPS, Tilt, River bank

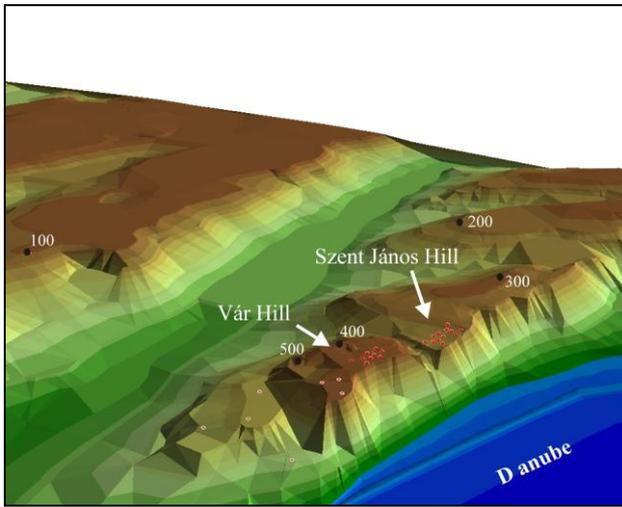
Figure 1. Digital terrain model of the Danube's high bank at Dunaszekcső and the GPS network (black dots: reference pillars, red dots: smaller benchmark points).

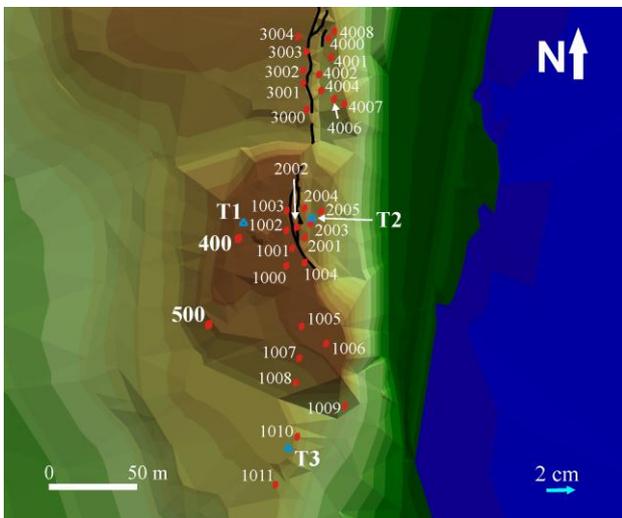
Figure 2. Study site and the geodetic network. Legend: 400-500: reference pillars, 1000-4008: smaller benchmark points, T1-T3: tiltmeters, black lines show the main ruptures after sliding on 12 February, 2008.
