## Monitoring of Tempi Valley Critical Rock Masses: Establishment of Special Monitoring Network and Procedures in Aegean Motorway S.A. Concession Project

**Key words:** *Tempi Valley; RIMM; RAS; critical rock masses; geodetic network; grout bridges*

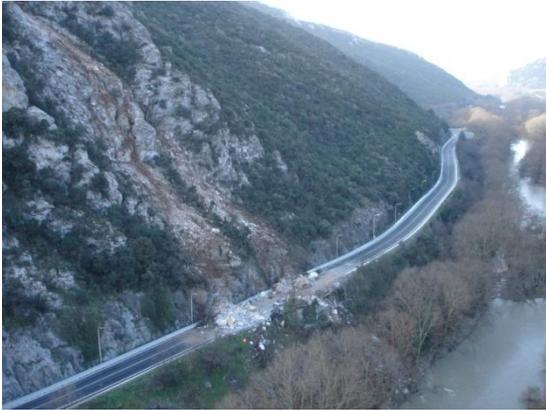
Figure 1. Tempi Valley rockfall 2009 by helicopter

Horio of Evritania region in 1963 that led to loss of 13 human lives and buried a whole village, the Panagopoula landslide in 1971, Tempi Valley rockfall in 2009 as presented in figure 1 & 2 that led to loss of a human life and the closure of the national road Athens – Thessaloniki for approximately 4 months, the Santorini rockfall in 2011 with one human loss, and many others.

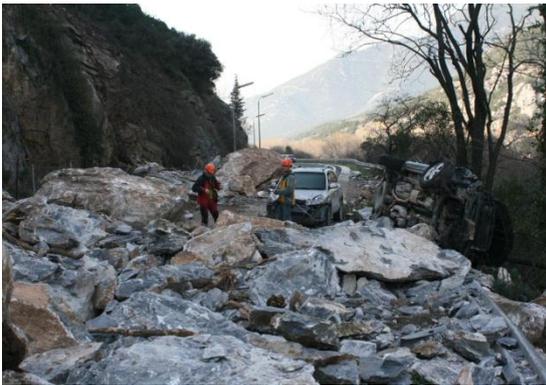
Figure 2. Tempi Valley rockfall 2009

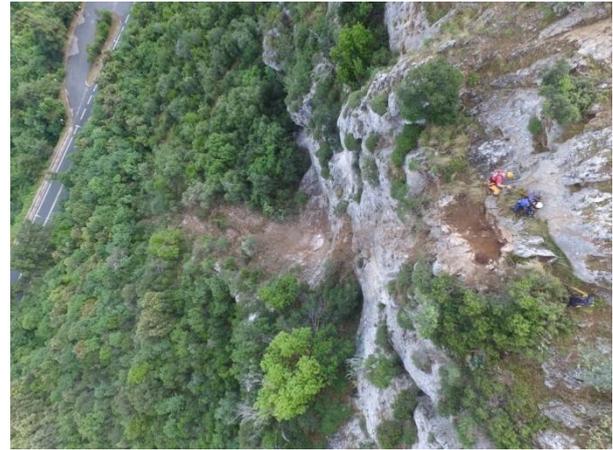
Figure 4. Inspection and scaling works

All parts of the barrier systems have to be controlled according to the maintenance manuals of the manufacturer. If parts of the system are damaged the diminution of the protection properties has to be evaluated and if necessary, immediate measures have to be taken. In case of damage to any of the rockfall protection measures, the damage report sheet has to be completed. In this sheet, damages to the rockfall protection are described, documented and classified with respect to the severity of the incident. The induced and finally completed measures are documented. Inspection and maintenance activities are presented in pictures 4& 5,

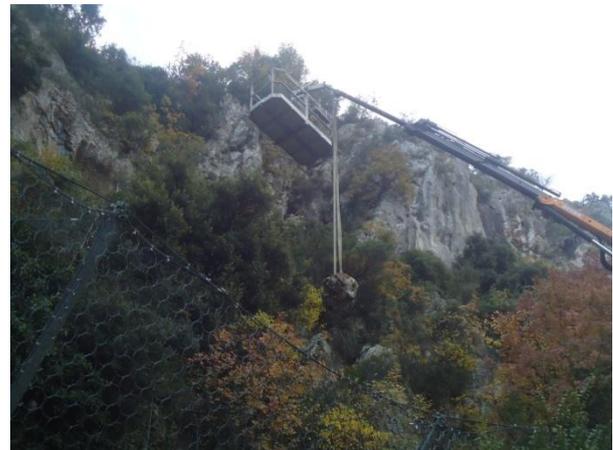
Figure 5. Emptying of barrier from trapped blocks

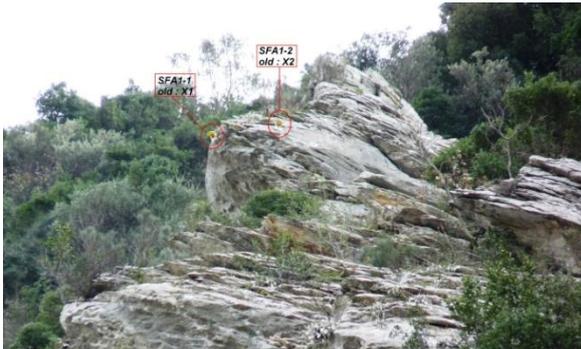
Figure 6. Prisms installed in special focused area SFA1.

Figures 6-8 of the installed geodetic network are presented below.

Prisms are mainly installed in special focused areas (SFAs). Monitoring is performed at least once per month and always after an extraordinary situation like

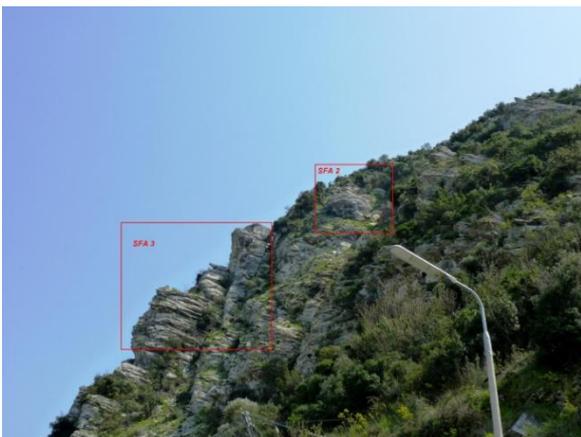
Figure 7. Special focused areas SFA2 & SFA3.

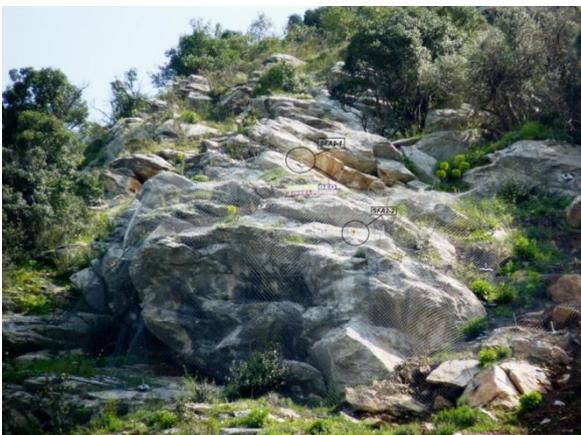
Figure 8. Prisms installed in special focused area SFA2.

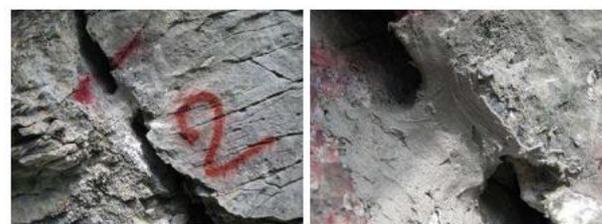
No 2A  
Installation Date: May 2012 (3rd bi-annual inspection by GEOTEST \_ installation by Greek Alpinists)

Figure 11. Detail of grout bridges

Moreover to the geodetic monitoring network, another network consisting of grout bridges is applied to rock discontinuities where movement is supposed to occur prior to failure (figures 10 & 11). Cracks in the grout bridges would indicate movement. In total almost 100 grout bridges have already been installed in Tempi Valley in various locations.

Details of the condition of all grout bridges are recorded in designated forms and evaluated. Condition of each grout bridge is compared with the initial condition right after its installation. A general rule is the installation of more than one grout bridges per
